Corvair 95: Stock was. . .

6 - Forced Air Heater

By Steven Spilatro

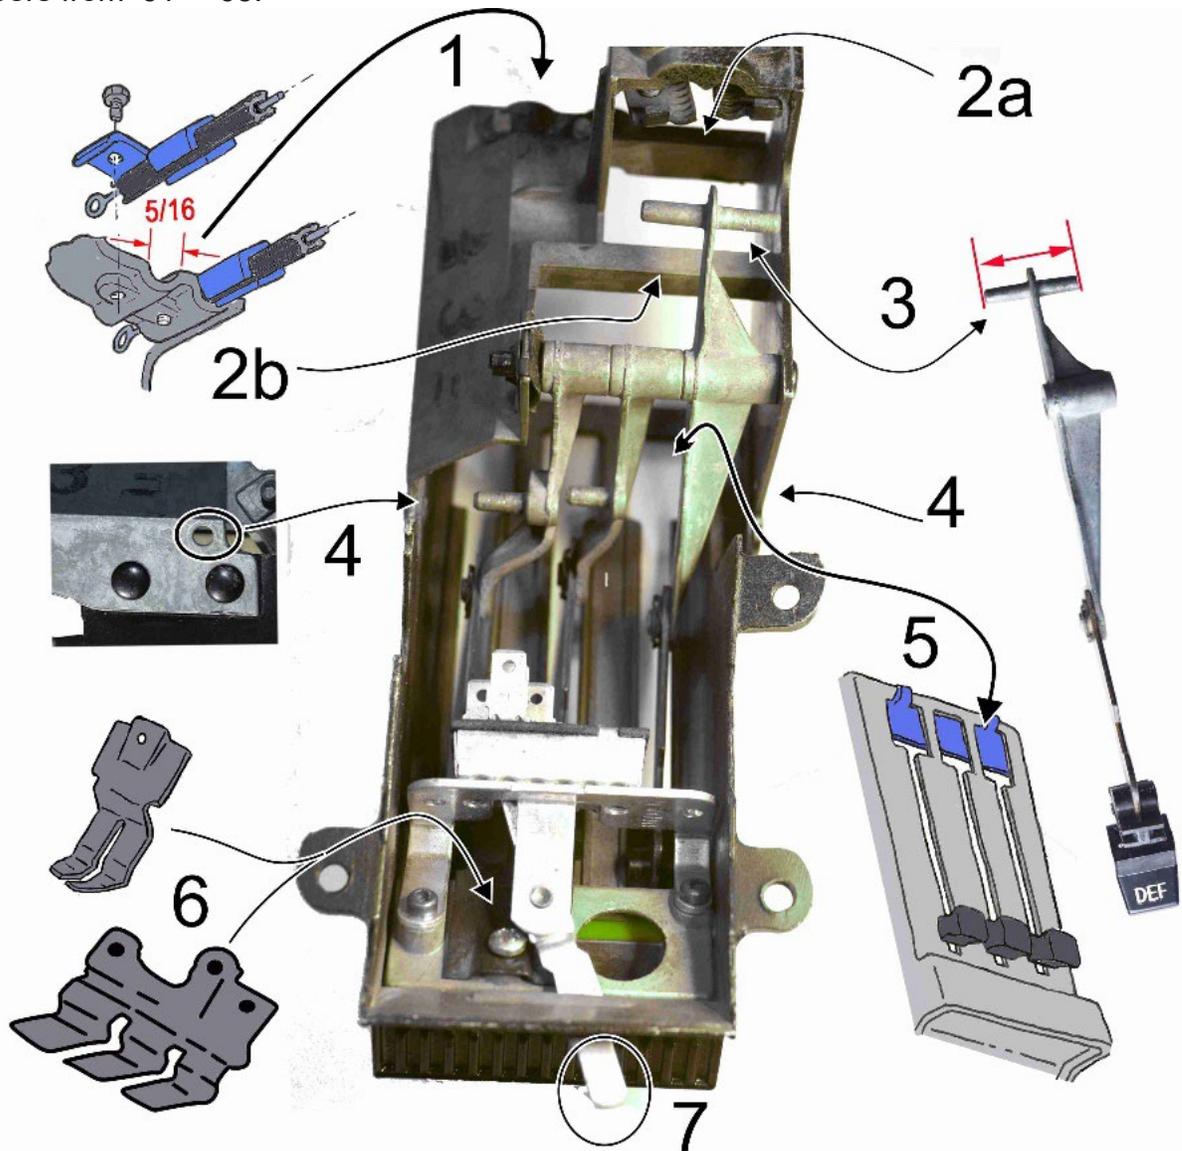
Dealers were notified of changes to the heater unit in Technical Service Bulletin DR552 (late 1962), which included changes to the control cables. Vehicles S110430 and F109386 were the first to receive control cables with wires cadmium coated to prevent corrosion and seizing within the housings. And now, instead of using small compression clamps, metal clips (#1 in the figure) were attached directly to the "air" and "heat" cables to better secure them to the control housing. To accommodate the new clips, the guides of the control housing into which the cables are secured were enlarged from a 3/16" to 5/16" diameter.

Later units have two pin holes (#4 in picture) on opposite sides of the housing through which a metal rod could be inserted to help align of the levers. The control housing was reinforced with cross bars (#2a & 2b in the picture), and because the bar

labeled “2b” also limited the downward throw of the levers, the metal retainer (#5) previously serving that purpose was discontinued.

Other changes also improved functioning of the heater control levers. The levers have a short pin around which the control cable wires connect. The pair of pins on the “Def” lever were lengthened from $\frac{3}{4}$ ” to 1” (#3 in the picture), and the pins of the “Air” and “Heat” levers were structurally reinforced. (The extra pin of the Def lever allowed connection of left- and right- side defroster control cable in cars.) At the front of the unit, the blower motor switch (#7) was modified such that the knob attached without need for a metal retainer. Below that lever in the heater lamp housing, a green lens was added in early ‘61.

Due to a proclivity of the control levers to slide unprovoked into “on” positions, a detent spring (#3830794; #6 in picture) was added to hold the air and heat levers in their off position. TSB DR552 shows this spring first appearing in August ‘62. However, later in the ‘63 model year GM decided to install a larger spring (#3832817; as shown in the 1963 assembly manual) that also serviced the “Def” lever. But this too would not stand, for we see this replaced in the ‘64 Assembly Manual by a different two-lever detent spring (#3734406), again for only the “Air” and “Heat” levers.

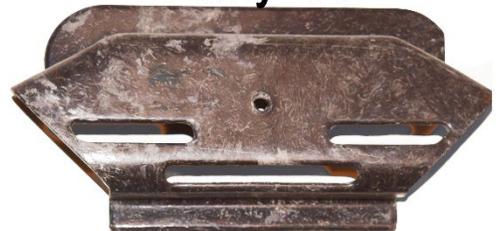
Early ‘61

Drivers in the temperate zone knew that warm air seemed to get lost on the way to the cab, and passengers in the cab were really left out in the cold! Resolving the latter problem necessitated a redesign of the front heater distributor (see picture) early in ‘61 model run. Although the part number appeared not to change, the engineering drawing for # 3786367 records changes between 7/2/60 and 2/9/61 in the size and number of the slots and the addition of an off-center partition to improve distribution of hot air in the cab. But the forced air heater ducting system that brought the air up from the rear was the architype leaky pipeline.

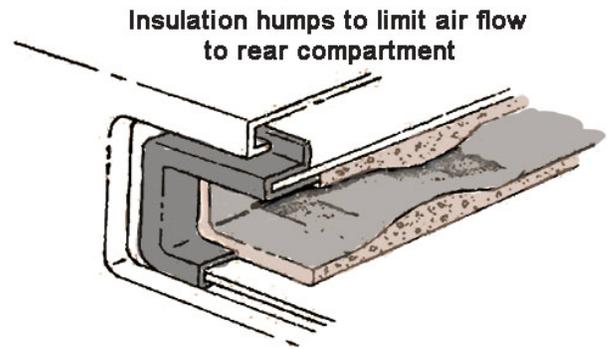
Conducting warm air from aft to fore of an FC was a persistent engineering challenge. Technical Service Bulletin DR 470 (March '61) offered an assortment of field repairs and production changes intended to improve air flow to the cab. One of the problems was the rear heater duct, which is sealed in pickups and Corvans, that directs air flow to the rear passenger of Greenbriers, alas, disproportionately so. An early mitigation were humps added to the insulation of the rear heater duct that constricted the air flow to the rear compartment.

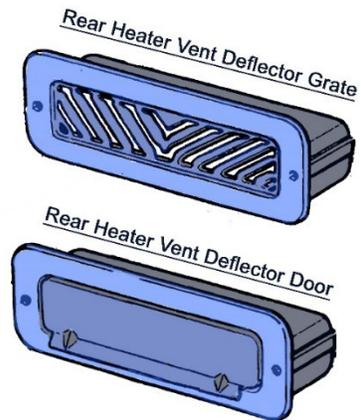
In February, 1961, a manual shut-off door for the rear heater duct (#3796164) was introduced. A small scale survey found that it was typically installed only in FCs with deluxe trim (RPO 431/Z60), which is surprising since the vent door is not among the features advertised for the deluxe trim package.

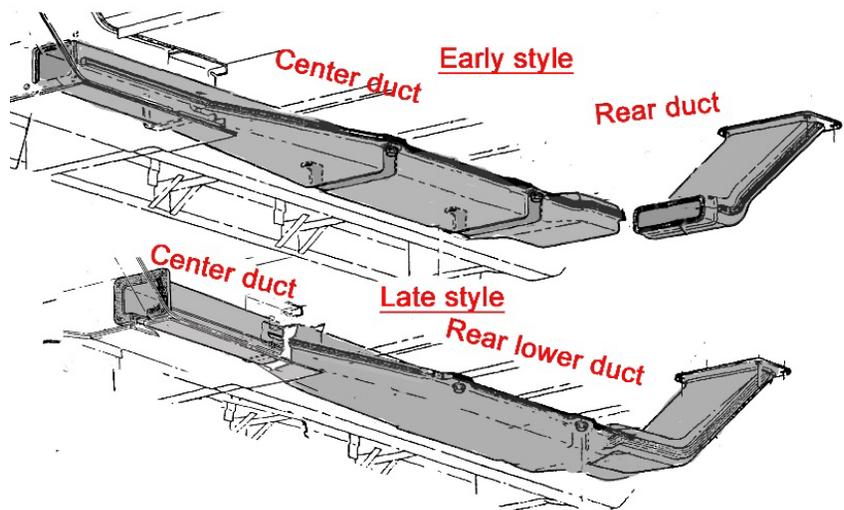
The conglomerated system of ducts that route air to the cab was a rather messy affair prone to leakage. In response to complaints, during the 1962 production run changes were made to several ducts and/or their seals. Most noticeably, the Rear (#3781789) and Center (#3781790) Duct assemblies were combined as the "Rear Lower Duct Assembly" (#3814135), and a newly designated "Center Duct" was created - a short metal sleeve that passes through the undercarriage outrigger and sill to the right front wheel well. Interestingly, in 1963, the metal straps that helped support the rear lower duct assembly were deleted in favor of direct bolting of the duct to the undercarriage, possibly another cost-savings measure.
