Corvair 95: Stock was. . .

1 - Clutch Cable and Shift Stabilizers

By Steven Spilatro

This article originally was published in Corvan Antics Jan-Feb 2019 volume 47(1)

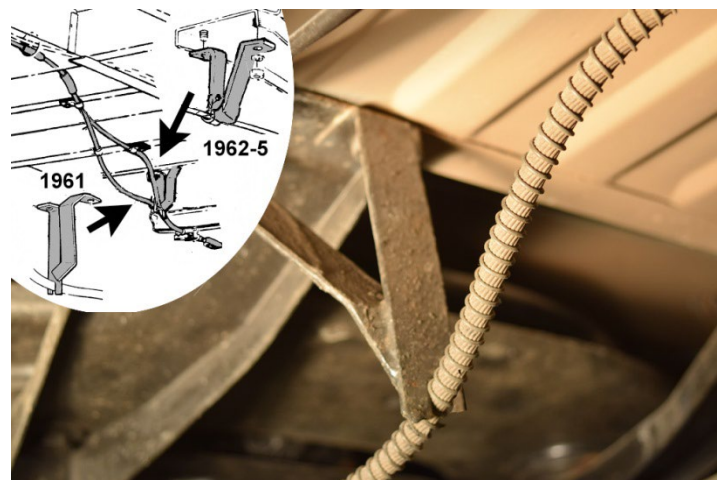
Streetwise only a few months in early 1961, the Corvair-95 needed its powertrain control system “tightened up” on several accounts. To reduce clutch chatter and slack, the clutch cable was shortened and its path across the undercarriage was redirected. The cable guide assembly (the metal bracket to which the cable mounts before its connection to the clutch rod) was also redesigned. The clutch cable casing was changed from nylon, which tended to absorb moisture, to Delrin which did not and afforded reduced friction.

Figure 1. 1961 Clutch cable bracket

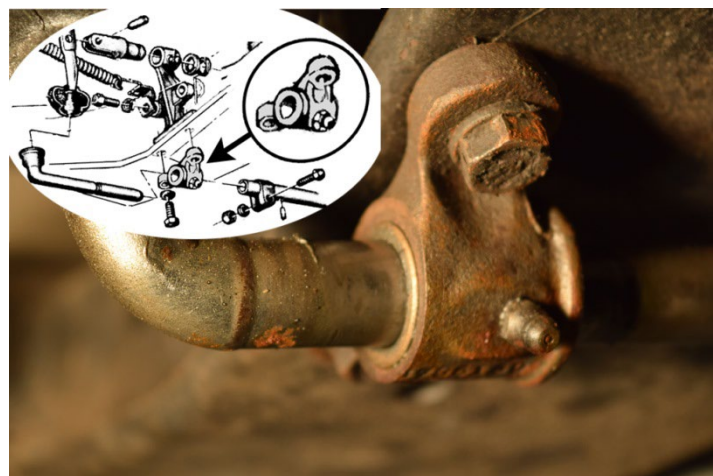
At some point all owners of early model FCs with standard transmissions must stare in amazement at the convoluted design of the shifter control, which negotiates a variety of pivots, couplings, brackets and boots on its way to the underside of the gas tank. While in the initial design the support bracket (# 3795730) on the lower side of the front cross member incorporated a brass bushing, this was eliminated (#3786168) mid 1961. In this highly exposed location the bearing was prone to fouling and, because the bottom angle of the crossmember was not adequately controlled, the bearing would sometimes bind.

Figure 2. Early shifter support bracket with brass bushing and grease fitting.

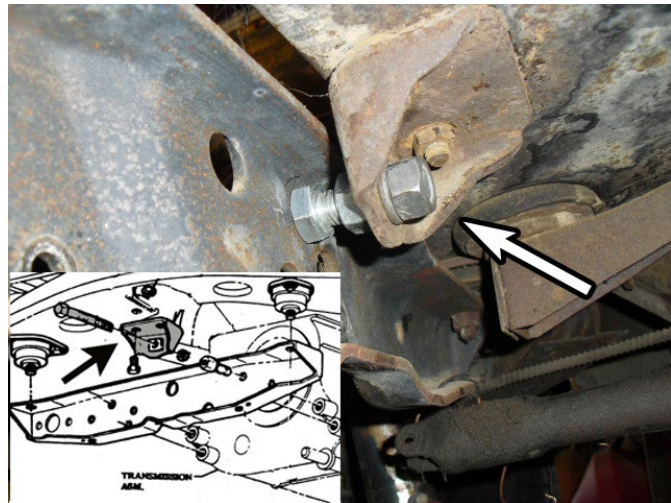
The first design fix was addition of a stabilizing bracket (#3799222) to the rear crossmember against which a jamb bolt would apply 10-20 inch-pounds of pressure on the engine forward support. The assembly is shown in the engineering layout L58501, drawn between 1-5-61 and 1-9-61. This design is called the "production fix" in DR-480 and shown in the 1961-63 assembly manuals. But this design was deemed unsatisfactory because the jamb bolt would bounce against the engine mounting bracket creating unsettling noises.

Figure 3. First design shift stabilizer with jamb bolt.

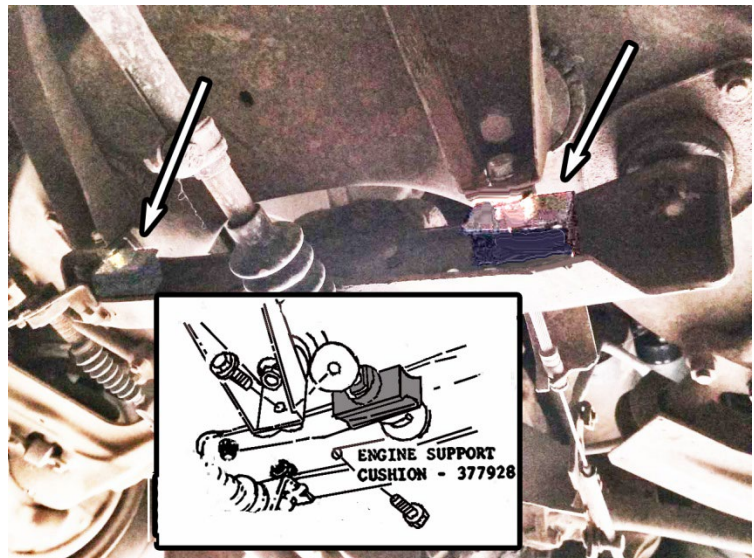
Figure 4. Second design shift stabilizer with rubber cushion.

The final design fix was a rubber cushion (#377928, a motor mount dating back to the 1930s) and steel washers inserted in the gap between the rear crossmember support brackets and the front engine mount. According to DR-480, this is the repair to be made for FCs already on the road. Maybe this ultimately was determined to be the better solution and became the final production change, but never made it into the assembly manuals.

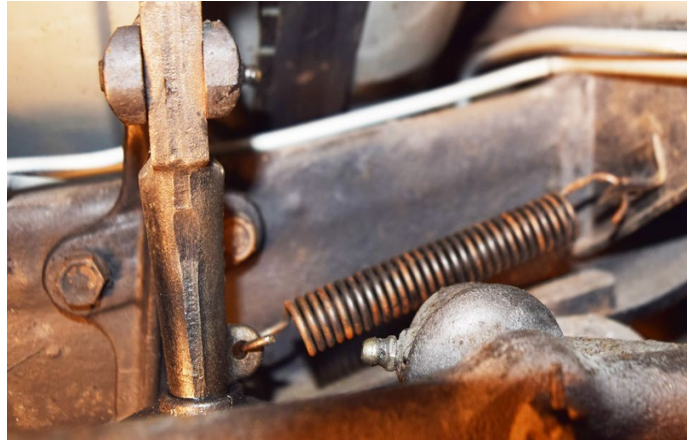
As part of the redesign to prevent transmission disengagement, DR-480 refers to the addition of an overcenter spring on the forward end of the shifter control rod. Originally, the shifter rod had a spring pulling horizontally from a tab below the pivot bracket to the undercarriage sill. Although the initial engineering drawings lack this spring, it probably was added to provide return action for the shifter and is present in early 1960 FC builds.

Figure 5. Early design shifter stabilizing spring.

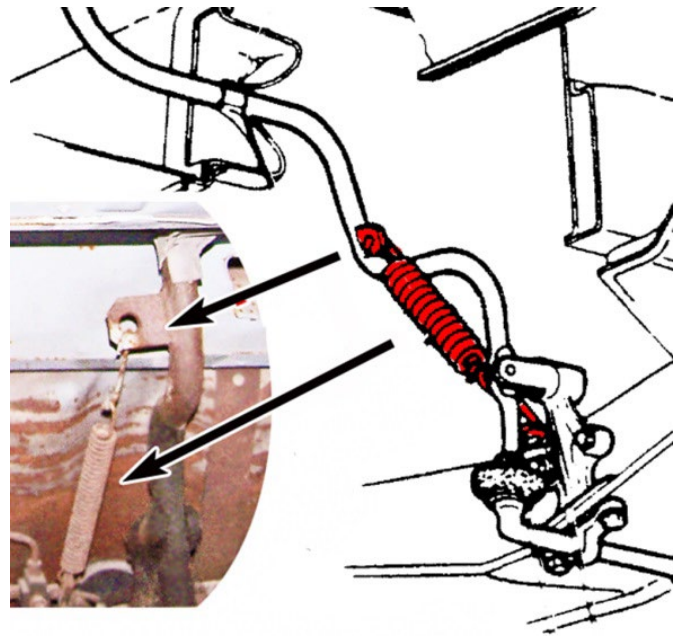
The overcenter spring described in DR-480 refers to a larger spring pulling on the shifter rod from a tab located above pivot bracket. This design is shown in engineering drawing dating to October – December 1960, and was continued until the introduction of the floor mounted shifter and linkage in 1963.

Figure 6. Later design shifter stabilizing spring.
