# Corvair 95: Stock was. . .

## 2 - Front and Side Doors

By Steven Spilatro

This article originally was published in Corvan Antics Nov-Dec 2019 volume 47(6)

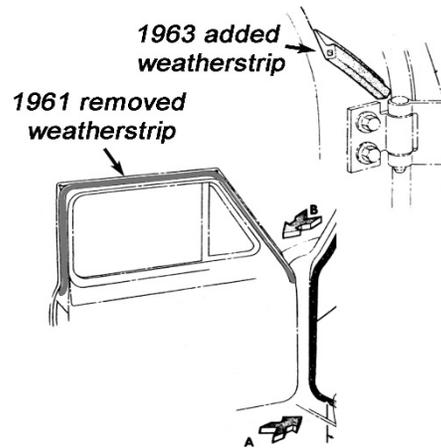
Figure 1. Front door weatherstrip.

which indicate adequate door sealing is provided with the remaining door opening seal". But sealing apparently was not adequate and persistent water seepage was addressed in 1963 by adding of a short piece of weatherstrip across the door jamb (Figure 1).

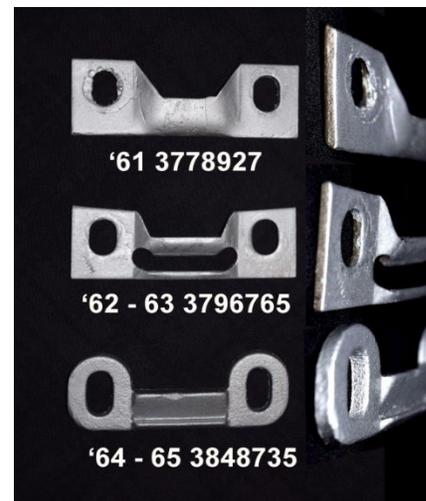
Figure 2. Side door

recognized the problem early-on and the new strikers (#3796765) introduced mid-1961 incorporated two notches to receive the latch pawl, greatly reducing the potential for the doors to suddenly swing open (Figure 2). Better, but still somewhat flimsy, the metal did not hold form well with repeated impact from the door bolt. Capitulating to necessity, the third generation door striker (#3848735) introduced in 1964 used much thicker gauge steel and eliminated the gap between the two catches. The bolt holes were also enlarged allowing a greater range of adjustment.

The willingness of the side doors of my '61 8-door Greenbrier to pop open when traveling over a rough road surface has long created anxiety. The problem is that its first design side door strikers (# 3778927) have a single locking notch over which the door can jiggle free, especially with a well-aged latch mechanism. GM

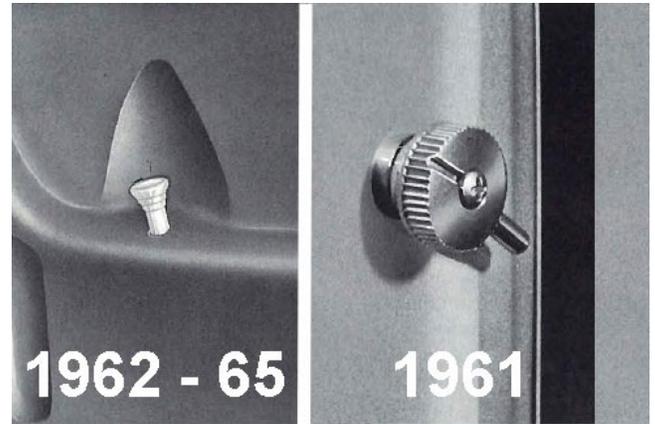
**Figure 3. Side door locking mechanisms.**

In 1962 several additional changes were made to the van side doors, including a redesign of the door latching and locking mechanism. The small twist-style inner door lock mechanism on the inner panel was replaced with a push button mechanism that extended through the inner door trim panel (Figure 3). The key lock on the outside of the forward intermediate door was also eliminated.

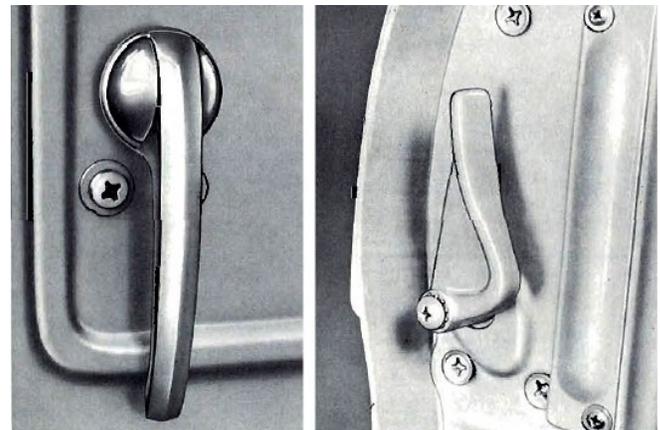
**1962 - 65** **1961**  
**Figure 4. Inside door handles**

Originally, the rear side door was opened from the inside with a “flipper”-like handle located on the door jamb (Figure 4). This was redesigned for the 1962 model year to be a standard type handle and relocated to from the jamb to the inside panel.

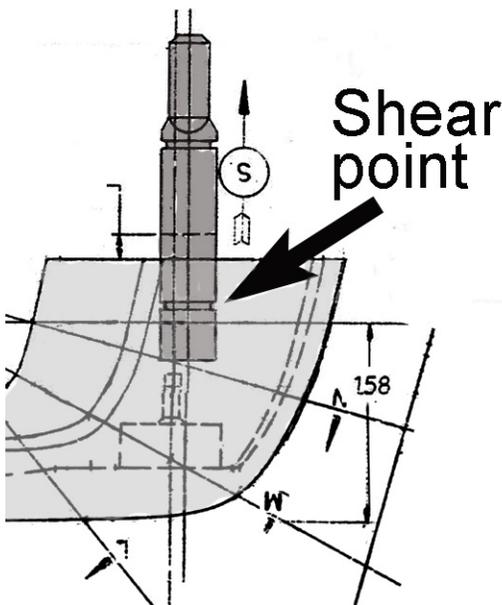
**Figure 5. Outside door handle.**

Some of the changes I've been discussing here were first described by Bob Kirkman, the Corvair engineer who served as CorvanAntics Technical Editor for many years. One of the more interesting design “tweaks” he described was to the outside intermediate door handles. For the original handles (3787331-2) it was found that with enough force applied on the handle the door could be forced open even if locked. To prevent this, a shear requirement was added to the design, causing the handle to break if too much force was applied (Figure 5). According to the engineering drawing

(3796367-8) of the modified door handles, the shaft will shear at 450-650 lbs of torque.

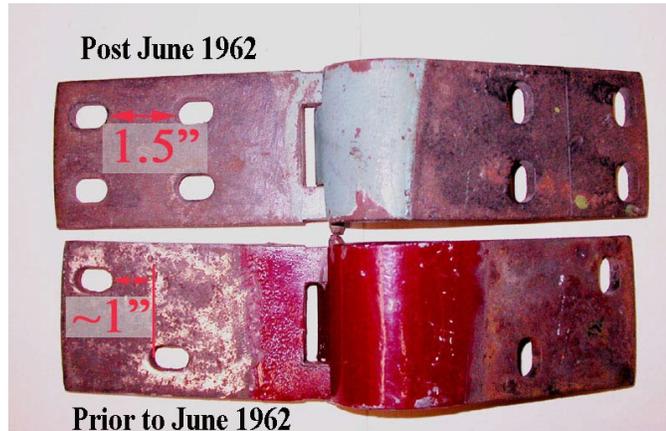
**Figure 6. Side door hinges.**

Originally, each hinge leaf had two slots, one for each of the hinge bolts (Figure 6). Because hinge leaves have different shapes and the upper and lower door hinges are different sizes, and when assembled the head of the pin must face upwards, to use a hinge on the optional left side doors, the pins needed to be removed and the hinges reassembled. Hinges with a modified design were used beginning late '62; because the spacing between the holes was changed, the hinges cannot be switched between different years.

In June 1962, the intermediate door hinges were modified.

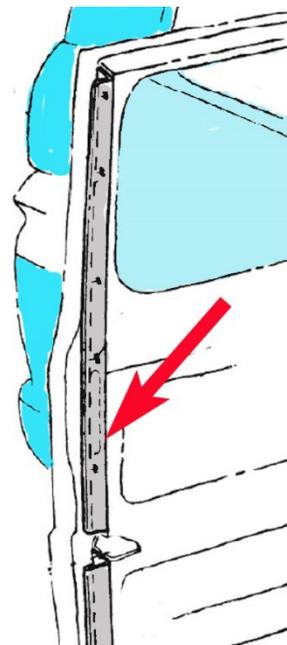
**Figure 7. Side door jamb extension**

The “door jamb extension assembly” (#3844821-2) became part of the Deluxe Trim (RPO Z60) equipment in 1964. These metal panels covered the opening between the side doors to prevent passengers from snagging or soiling clothing on the door jambs (Figure 7). I believe that these were originally only used on FC taxicabs, part of the RPO 420 package, where they were referred to as “door striker covers”.
