Corvair 95: Stock was. . .

3 - Rear Door

By Steven Spilatro

This article originally was published in Corvan Antics Mar-Apr 2020 volume 48(1)

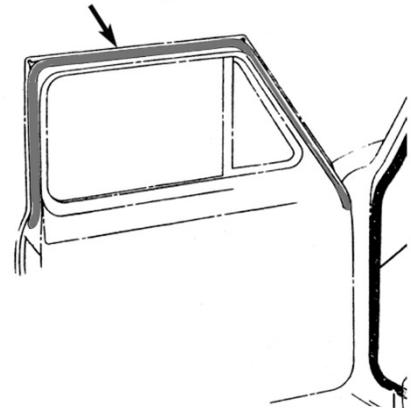
1961 removed weatherstrip

Fig 1. Front door weatherstrip

In the previous article I had discussed changes to the front doors. However, I missed another early '61 modification, deletion of the weatherstrip (#3778499) attached to the door itself. This is shown but not labeled on page 113 of the '61 assembly manual and noted as removed. Deletion, noted in the 1962 Truck Engineering Features booklet, was "a result of tests which indicate adequate door sealing is provided with the remaining door opening seal". But as already noted, apparently not, since it was necessary to add the short weatherstrip in 1963, as previously noted.

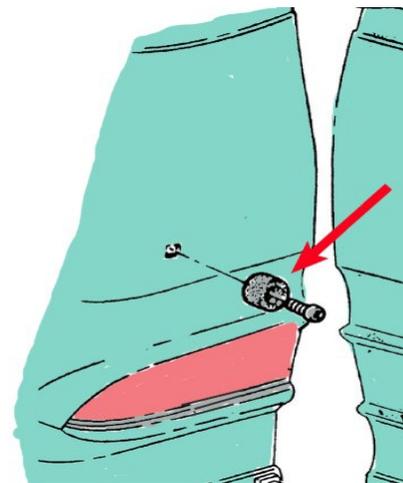
Fig 2. Location of rear door outer bumper

Why keep a bumper that gets no thump? That question has been much pondered by FC owners when looking at the "rear door outer bumpers" located on the rear corner body panels. The origin and history of these bumpers has been tied to that of the rear door hinges, which as originally designed allowed the doors to open far enough to hit the rear corners. But even after the door hinges were modified to limit the swing of the doors, the bumpers were still installed. This conundrum disappears if cushioning a door thump were not their sole purpose, which I believe is the case.

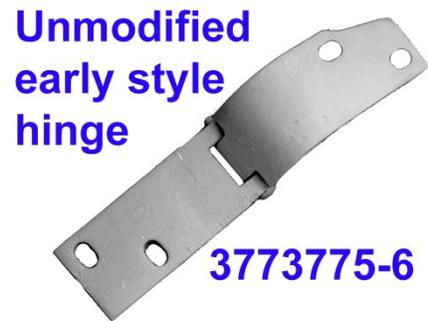
Fig 3. Early style FC rear door hinge

From 1961 - '63 van rear doors used L & R hinges #3773775-6, easily identified by their three interlocking knuckles. Like the side cargo doors, the rear doors could open far enough to reach the body panels. To cushion the impact, "rear door outer bumpers" were placed on the rear corner body panels, but as mentioned these were not sufficient under some circumstances.

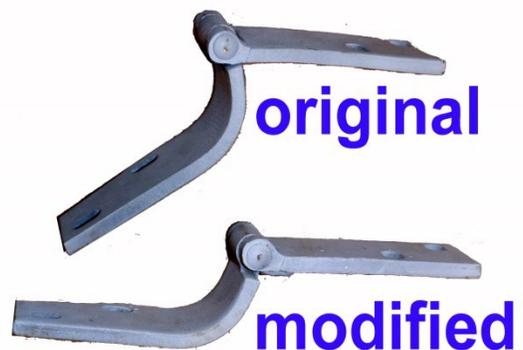
Fig 4. Rotation of original and modified rear hinges.

With production underway, a solution was needed quickly. The decision was to modify the hinges by welding on a metal tab that would limit how far the doors could open. This would have been faster and cheaper than scrapping the stock pile of hinges already on hand and creating the dies to forge new ones.

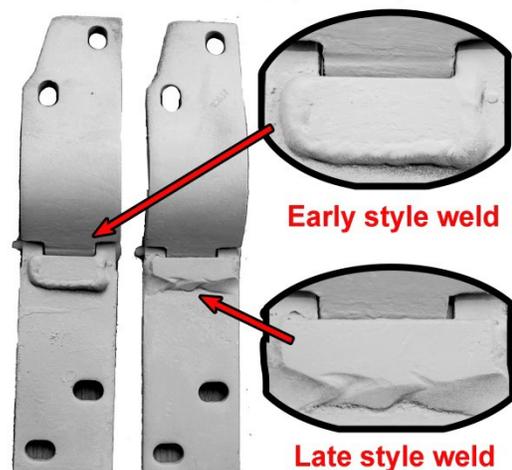
Fig 5. Early and Late Style Hinge Welds

Some early vans have unmodified upper hinges but lower hinges with a small welded metal tab. This looks like a preliminary fix possibly performed at the Flint or St Louis assembly plants. The weld is not ground smooth and applied only to a single hinge per door – sufficient to keep the door away from the corner and not slow assembly any more than necessary. Eventually, both upper and lower hinges received a larger metal tab and the weld was ground smooth (more or less, as shown in the picture). This style hinge is found on essentially all '61 – '63 vans. Which leads us back to the original question, why were the bumpers still installed if the doors could no longer reach them?

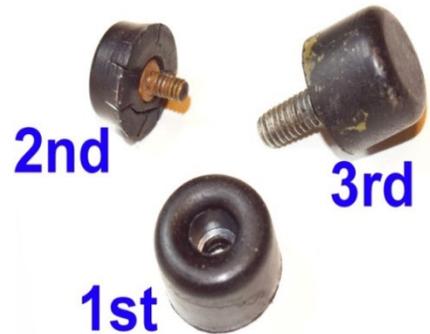
Fig 6. Three designs of rear door outer bumpers

The 1961 assembly manual and parts catalogs identify “first” and “second” design bumpers. The original bumper was #3785718 (#1 in the picture), making it the same as those used as the side door bumpers. This bumper attaches via a pass-through screw to a plastic clip mounted in a square hole in the body panel.

But already in the 1961 assembly manual, the original bumper was superseded by bumper #3812749, which is the bumper identified as #3 in the picture. The 5/16-18 bolt of this bumper would not fit the original square hole and required a larger round hole in the corner panel. However, I have seen several '61 – '62 vans with a bumper similar to #2 with a smaller gauge bolt, possibly an undocumented interim bumper used with preexisting panels with the square hole.

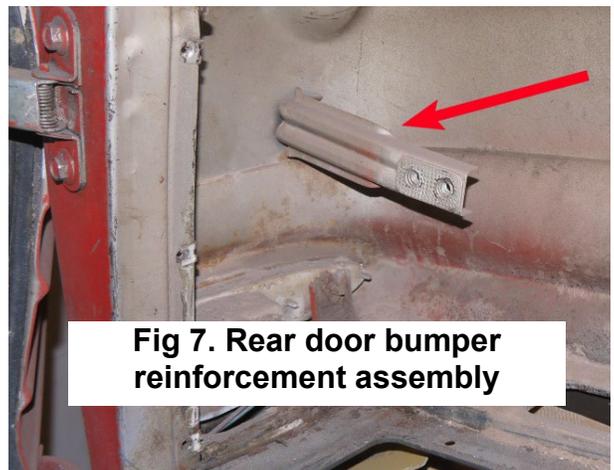
Fig 7. Rear door bumper reinforcement assembly

The larger bolt of the “second” design bumper began to serve its function in mid-1962 when the “Rear door bumper reinforcement assembly” (#3812732) was introduced. This metal bracket located behind both left and right corners (see picture) was secured to the bumper bolt and attached to the rear interior body panel. As the name conveys the bracket served to strengthen the rear panel corners against minor impacts, not from the doors but other from other assaults. The bracket was installed through the 1963 production year.

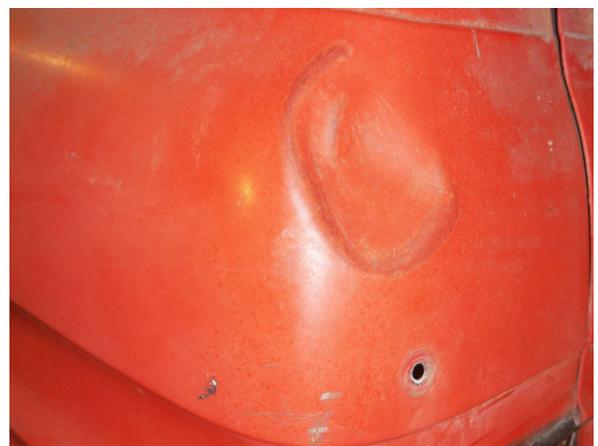
Fig 8. Typical rear corner dent.

Let's first consider the problem involving the rear corners of the vans. As production of the FCs commenced in September 1960, the assembly lines reported that the rear corners of the vans were more frail and susceptible to damage than expected. The Flint and St Louis assembly line built the vans using body units preassembled at the Chevrolet Indianapolis plant, which included large side panel units with the rear corners attached. It would have been no small problem to have the corners of these large side units damaged during shipment or assembly. The assembly lines also found that the corners could be dented from a rear door, possibly caught by the wind, that vigorously swung open and hit the corner. These concerns would have extended to the vehicles after being sold and on the road.

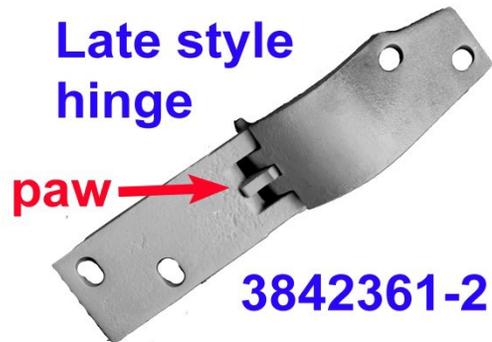
Fig 9. Late style FC rear door hinge

remedy this, the hinge was reengineered. The new hinge (#3842361-2) had 4 knuckles and a center paw that checked the rotation of the hinge by striking an edge rather than surface of the hinge, thus preventing paint damage. This hinge first appears in the 1963 assembly manual, but installation appears not to have occurred until 1964.

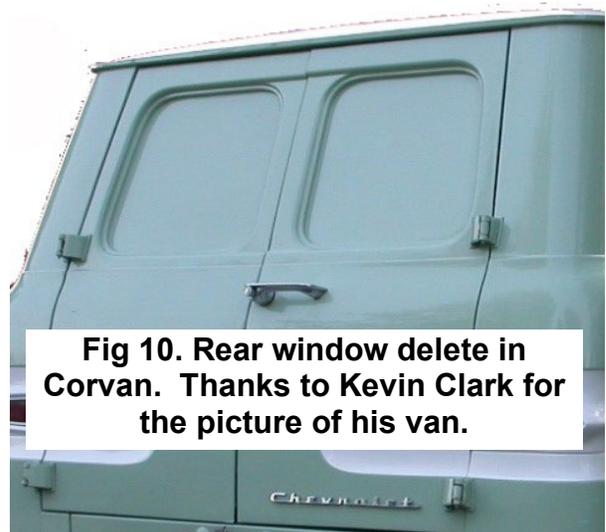
Fig 10. Rear window delete in Corvan. Thanks to Kevin Clark for the picture of his van.

Those cost saving deletions imposed in 1963 have been much discussed in the past. Since we're focusing on the rear doors, this is a good time to mention that one of those measures was elimination for Corvans of the rear door windows as a stock item. The rear door windows became RPO A12, and this reflected forward to the left front door. Since in the absence of rear windows the inside rear view mirror was superfluous, it was also eliminated as a stock item. But GM did understand that is important for a driver to know what's behind the van, so the round outside rear view mirror on the driver side door (which was RPO D32 for other FCs) became standard for Corvans models. If option RPO A12 (rear window) was ordered, the inside rear view mirror was restored and the ORVM was removed.

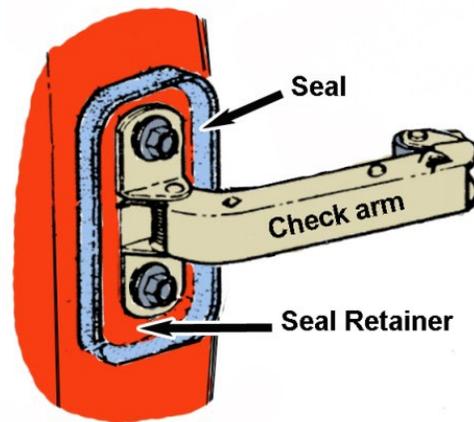
Fig 12. Side or rear door check arm.

Another cost-saving change was elimination of the check-arm rubber seals and seal retainer metal plates. These gaskets are moisture seals for the door openings into which the check arms insert. These were first deleted from Corvans in 1962, and in 1963 there was a plan to remove all the check arms and replace them with a canvas strap, but this change was canceled as shown in the '63 assembly manual. However, a decision was to additionally eliminate the rubber seal and its retainer from the rear doors of the Greenbrier.
