Corvair 95: Stock was. . .

2 - Front and Side Doors

By Steven Spilatro

This article originally was published in Corvan Antics Nov-Dec 2019 volume 47(6)

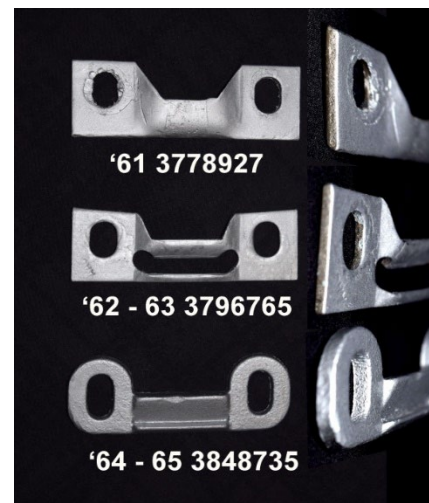
Figure 2. Side door

recognized the problem early-on and the new strikers (#3796765) introduced mid-1961 incorporated two notches to receive the latch pawl, greatly reducing the potential for the doors to suddenly swing open (Figure 2). Better, but still somewhat flimsy, the metal did not hold form well with repeated impact from the door bolt. The third generation door striker (#3848735) introduced in 1964 used much thicker gauge steel and the bolt holes were also enlarged allowing a greater range of adjustment. Also, the gap between the two catches was eliminated, probably to allow easily closing of the doors. As the 1964 Truck Engineering Features book explains, the side doors strikers were shortened to allow easier closure of the doors. Since the strikers did not extend downward as far, the gap between the catches was no longer necessary.

The willingness of the side doors of my '61 8-door Greenbrier to pop open when traveling over a rough road surface has long created anxiety. The problem is that its first design side door strikers (# 3778927) have a single locking notch over which the door can jiggle free, especially with a well-aged latch mechanism. GM

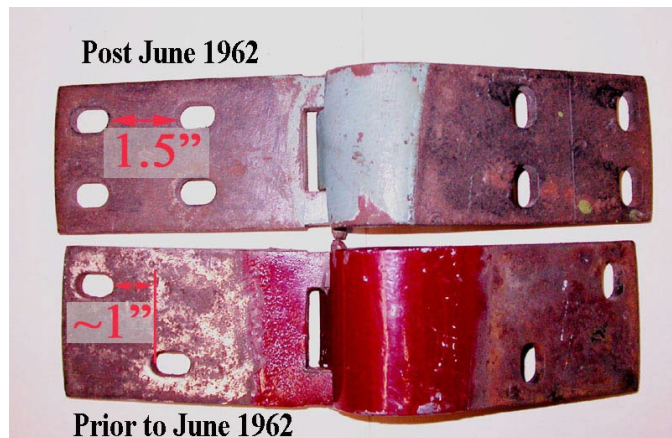
Originally, each hinge leaf had two slots, one for each of the hinge bolts (Figure 6). Because hinge leaves have different shapes and the upper and lower door hinges are different sizes, and when assembled the head of the pin must face upwards, to use a hinge on the optional left side doors, the pins needed to be removed and the hinges reassembled. Hinges with a modified design were used beginning late '62; because the spacing between the holes was changed, the hinges cannot be switched between different years.

Figure 6. Side door hinges.

In June 1962, the intermediate door hinges were modified.
