Corvair 95: Stock was. . .

3 - Rear Door

By Steven Spilatro

This article originally was published in Corvan Antics Mar-Apr 2020 volume 48(1)

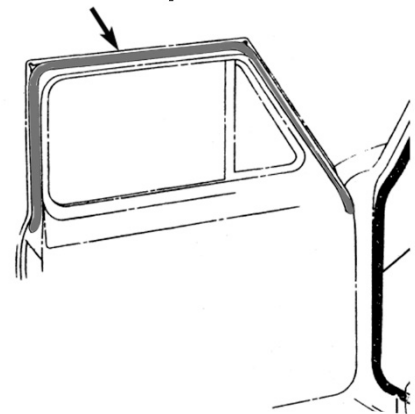
Fig 1. Front door weatherstrip

1961 removed weatherstrip

In the previous article I had discussed changes to the front doors. However, I missed another early '61 modification, deletion of the weatherstrip (#3778499) attached to the door itself. This is shown but not labeled on page 113 of the '61 assembly manual and noted as removed. Deletion, noted in the 1962 Truck Engineering Features booklet, was "a result of tests which indicate adequate door sealing is provided with the remaining door opening seal". But as already noted, apparently not, since it was necessary to add the short weatherstrip in 1963, as previously noted.
