Corvair 95: Stock was. . .

6 - Forced Air Heater

By Steven Spilatro

This article originally was
published in Corvan Antics
Jul - Aug 2021 volume 49(4)

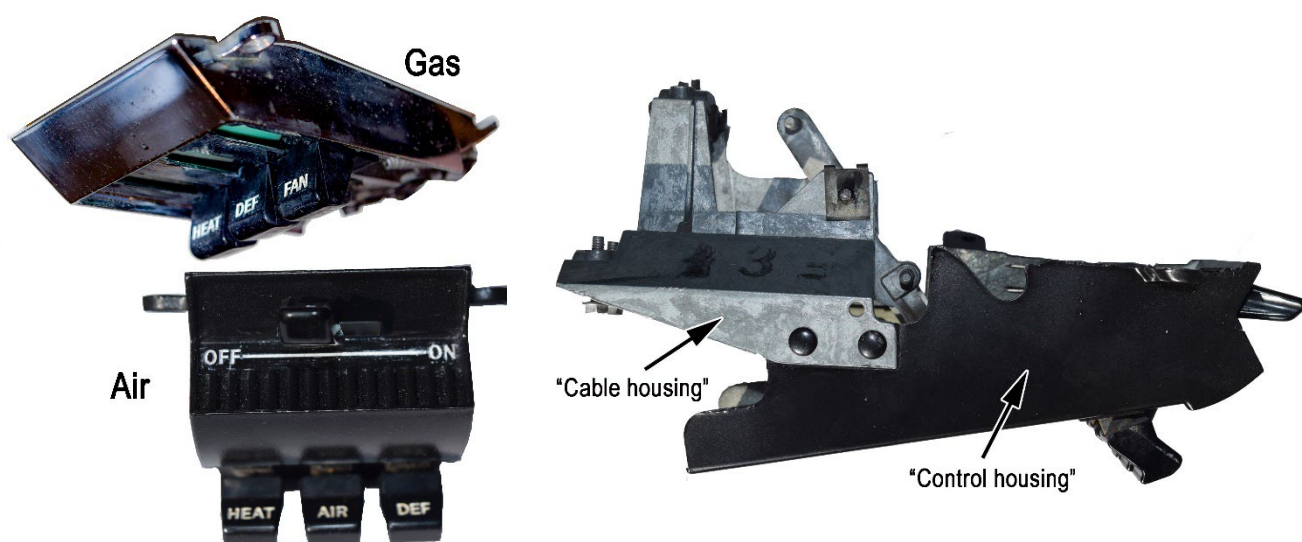
Heater control

FCs with forced air and gas heaters used different control assemblies. The control unit for the gas heater was chrome and the same as used in the car. Control units for the forced air heater were largely the same for the FC and car through 1964, sometimes sharing the same part numbers.

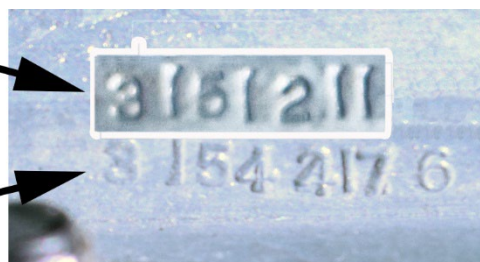
Original

With "4476"
over-strike

The control housing was part #3151172 and did not change over the years. The cable housing of the '61 silver control unit was part #3151211 and became #3154476 in black units when later modified. Oddly,

renumbering of the new cable housing seemed to be an oversight - the "4476" of the new number was embossed over top of the "1211" of the original number. GM assigned numbers to the complete housing assemblies, which passed through 5 different part numbers from '61 - '65.

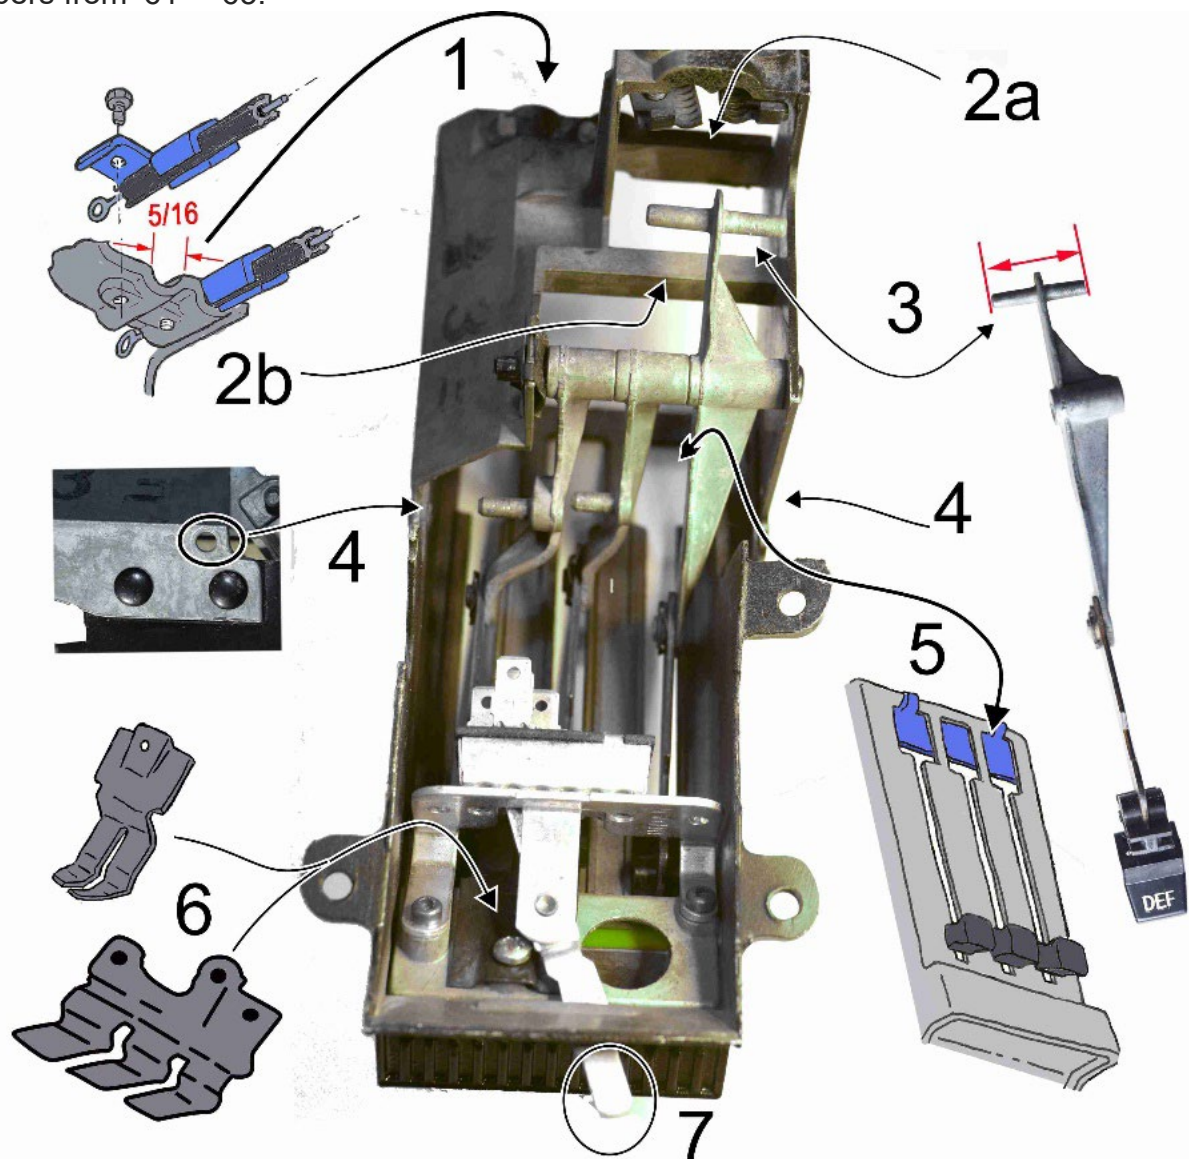
Later units have two pin holes (#4 in picture) on opposite sides of the housing through which a metal rod could be inserted to help align of the levers. The control housing was reinforced with cross bars (#2a & 2b in the picture), and because the bar

labeled “2b” also limited the downward throw of the levers, the metal retainer (#5) previously serving that purpose was discontinued.

Due to a proclivity of the control levers to slide unprovoked into “on” positions, a detent spring (#3830794; #6 in picture) was added to hold the air and heat levers in their off position. TSB DR552 shows this spring first appearing in August ‘62. However, later in the ‘63 model year GM decided to install a larger spring (#3832817; as shown in the 1963 assembly manual) that also serviced the “Def” lever. But this too would not stand, for we see this replaced in the ‘64 Assembly Manual by a different two-lever detent spring (#3734406), again for only the “Air” and “Heat” levers.

Other changes also improved functioning of the heater control levers. The levers have a short pin around which the control cable wires connect. The pair of pins on the “Def” lever were lengthened from $\frac{3}{4}$ ” to 1” (#3 in the picture), and the pins of the “Air” and “Heat” levers were structurally reinforced. (The extra pin of the Def lever allowed connection of left- and right- side defroster control cable in cars.) At the front of the unit, the blower motor switch (#7) was modified such that the knob attached without need for a metal retainer. Below that lever in the heater lamp housing, a green lens was added in early ‘61.

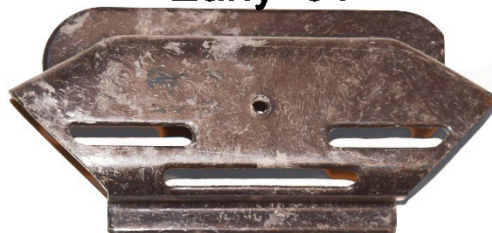
Early ‘61

Drivers in the temperate zone knew that warm air seemed to get lost on the way to the cab, and passengers in the cab were really left out in the cold! Resolving the latter problem necessitated a redesign of the front heater distributor (see picture) early in ‘61 model run. Although the part number appeared not to change, the engineering drawing for # 3786367 records changes between 7/2/60 and 2/9/61 in the size and number of the slots and the addition of an off-center partition to improve distribution of hot air in the cab. But the forced air heater ducting system that brought the air up from the rear was the archtype leaky pipeline.

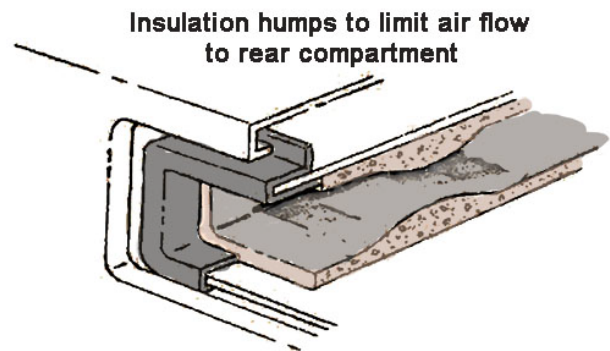
Conducting warm air from aft to fore of an FC was a persistent engineering challenge. Technical Service Bulletin DR 470 (March '61) offered an assortment of field repairs and production changes intended to improve air flow to the cab. One of the problems was the rear heater duct, which is sealed in pickups and Corvans, that directs air flow to the rear passenger of Greenbriers, alas, disproportionately so. An early mitigation were humps added to the insulation of the rear heater duct that constricted the air flow to the rear compartment.

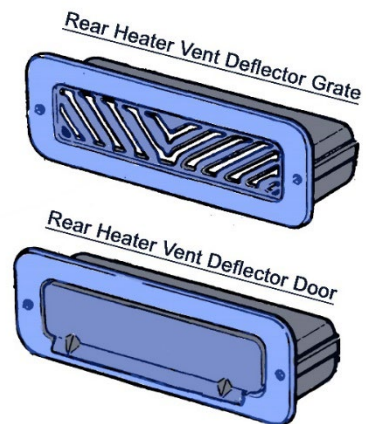
In February, 1961, a manual shut-off door for the rear heater duct (#3796164) was introduced. A small scale survey found that it was typically installed only in FCs with deluxe trim (RPO 431/Z60), which is surprising since the vent door is not among the features advertised for the deluxe trim package.

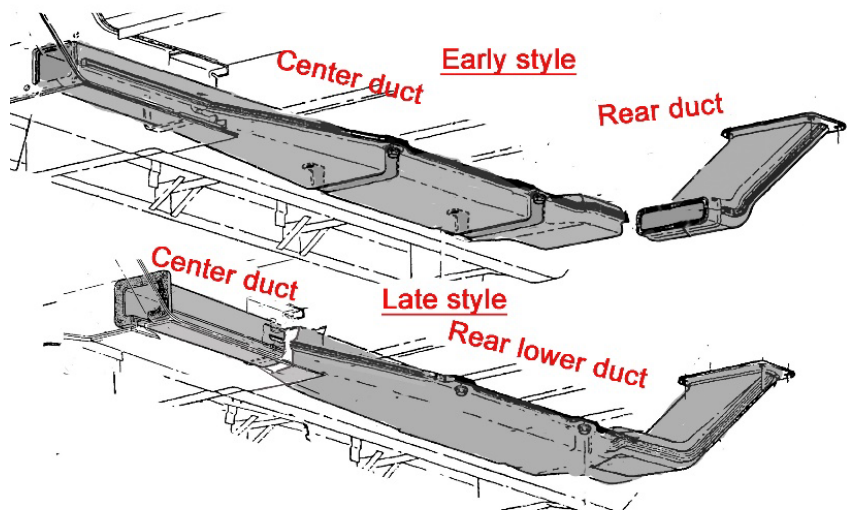
The conglomerated system of ducts that route air to the cab was a rather messy affair prone to leakage. In response to complaints, during the 1962 production run changes were made to several ducts and/or their seals. Most noticeably, the Rear (#3781789) and Center (#3781790) Duct assemblies were combined as the "Rear Lower Duct Assembly" (#3814135), and a newly designated "Center Duct" was created - a short metal sleeve that passes through the undercarriage outrigger and sill to the right front wheel well. Interestingly, in 1963, the metal straps that helped support the rear lower duct assembly were deleted in favor of direct bolting of the duct to the undercarriage, possibly another cost-savings measure.
