## CORVAIR 988063 RADIO ANTENNA INSTRUCTION SHEET

500 & 700 SERIES

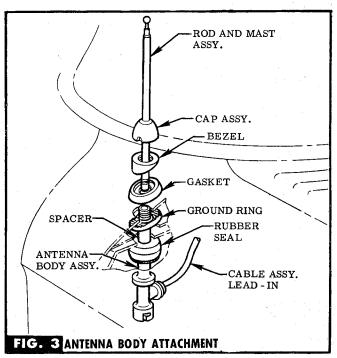
STEP 3 REMOVE RIGHT HAND COWL KICK PAD FROM INSIDE OF CAR. ATTACH CABLE ASSY. LEAD-IN TO ANTENNA BODY ASSY. DROP SPACER AND RUBBER SEAL ONTO

ANTENNA BODY ASSY. AS SHOWN IN FIG. 2.

STEP 4 DROP ROD AND MAST ASSY. INTO ANTENNA BODY ASSY. AND USE THIS ASSY. AS GUIDE FOR PLACING GROUND RING TO UNDER SIDE OF FENDER SURFACE AS SHOWN IN LOCATION IN FIG. 2 AND 3. PUSH ANTENNA BODY ASSY. UP INTO PLACE AND RETAIN WITH GASKET, BEZEL, AND CAP NUT. TIGHTEN WITH FINGERS, TO OUTSIDE OF FENDER.

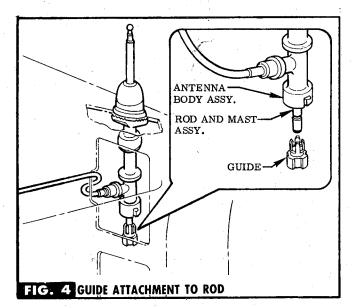
STEP 5 ATTACH GUIDE TO BOTTOM OF ROD AND MAST ASSY. AS SHOWN IN FIG. 4.

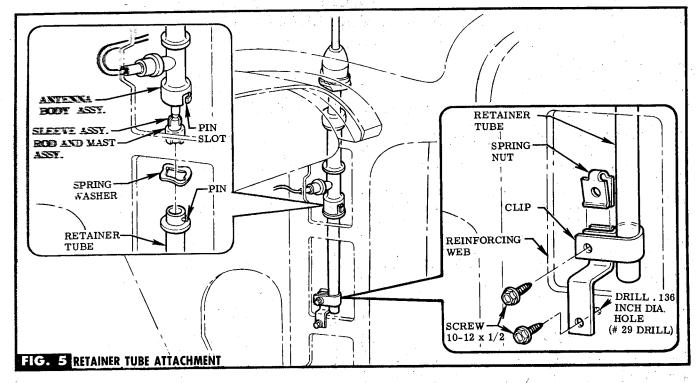
STEP 6 PLACE SPRING WASHER ON SHOULDER OF RETAINER TUBE. FROM INSIDE OF VEHICLE ATTACH RETAINER TUBE TO ANTENNA BODY ASSY. BY INSERTING PIN IN SLOT & TURNING TO LOCK IN PLACE, SEE FIG. 5.

STEP 7 PLACE CLIP ON BOTTOM OF RETAINER TUBE & ATTACH CLIP TO BRACKET WITH SCREW & SPRING NUT. PLACE BRACKET AGAINST REINFORCING WEB, TIGHTEN SCREW IN THE CLIP & SPRING NUT SECURELY. SEE FIG. 5.

**STEP 8** USING REMAINING HOLE IN BRACKET AS A TEMPLATE, DRILL A HOLE IN SHROUD PANEL. ATTACH BRACKET TO SHROUD PANEL SECURELY WITH REMAINING SCREW. REPLACE COWL KICK PANEL, REMOVED IN STEP 3. SEE FIG. 5.

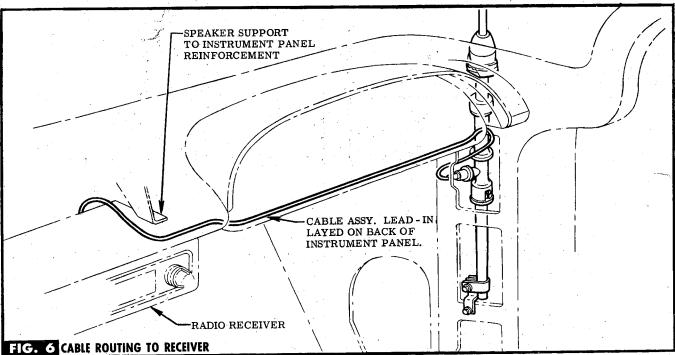
**STEP 9** ROUTE LOOSE END OF CABLE ASSY.-LEAD IN BACK OF INSTRUMENT PANEL, & PLUG INTO RADIO RECEIVER. SEE FIG. 6.
