Corvair 95: Stock was. . .

4 - Other Doors, and Emblems

By Steven Spilatro

This article originally was published in Corvan Antics Sep-Oct 2020 volume 48(5)

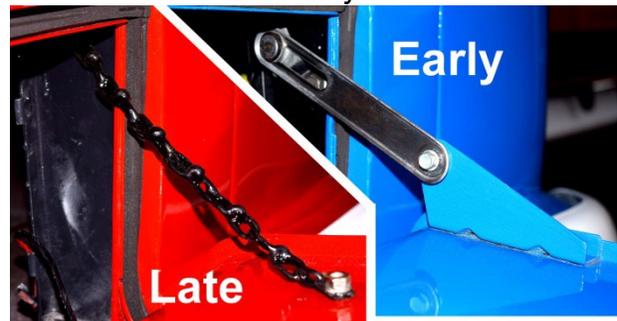
Overall, the early style engine access door was a rather clumsy affair. Its purpose was to allow inspection, minor repairs and tuning of the engine without having to remove the engine cover. The latch often did not adequately pull the door tight against the seal, especially if the panel had been bent from mechanics leaning on it. The little door latch handle was a flimsy affair and awkwardly designed to curve around and over the license plate.

Open, the door was supported with a pair of check arms that folded back when the door was shut. Subject to oil, dirt and grime the check arms tended to foul and hang-up when opening and closing. Ostensibly to rectify this problem but probably also as a cost reduction, in mid-'62 the check arms were replaced by rubber coated metal chains that bolt to the door. Too bad I feel, because the bolt heads are exposed on the exterior of the door.

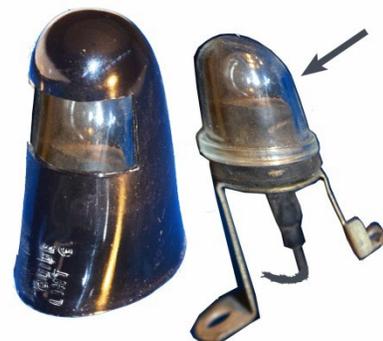
Speaking of those early style light housings (#5952343) that straddle the license plate, they were accident-prone because they were one of the few plastic items in the whole vehicle. Inside the housings was the lamp socket assembly (#5952682). Now, maybe this is best filed under "Stock wasn't but should've", but the 1960 - 61

Corvair car used a similar lamp socket (#5952338), that also incorporated a clear thimble-shaped glass lens (#5949532). That lens fits perfectly the FC unit, begging the question whether it was intended for FCs also. Alas, the evidence suggests not; the lens is not shown in the FC assembly manuals and the parts and accessories catalogs list the lens for vehicles “exc. Lakewood, FC” – probably another cost-savings measure. Nevertheless, it’s a nice addition if you can find them.

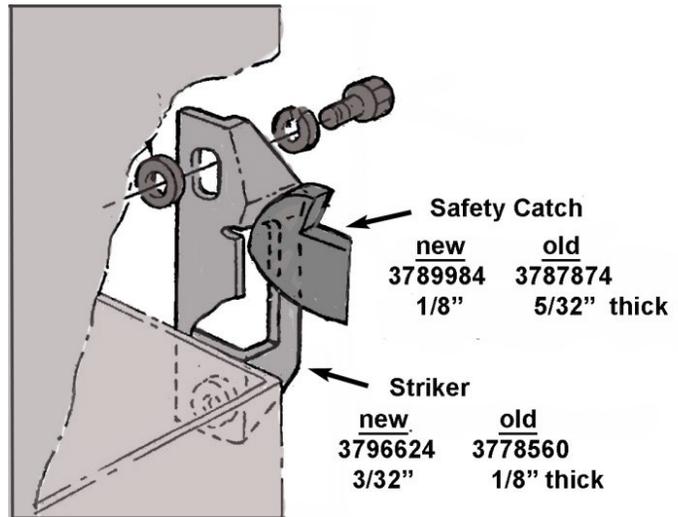
OK, well technically not doors, but both open. Around February 1961, the latches of the R1254 rampgate were modified. As explained in Technical Service Bulletin DR-464, the primary locks and safety catch for the rampgate were modified to improve gate retention for all pickups beginning with F102775 (in Flint) and S107214 (in St Louis). The length of the primary lock bolts and the size of the safety catch hook were slightly increased, and the former lip-type striker was replaced with a new window-type opening to receive the hook, preventing the hook from disengaging. Additionally the loop of the safety catch release handle was enlarged.

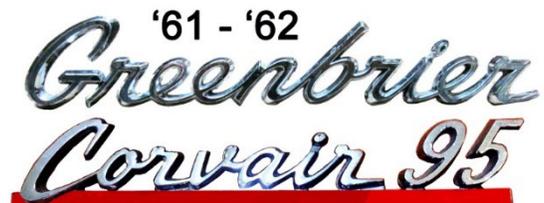
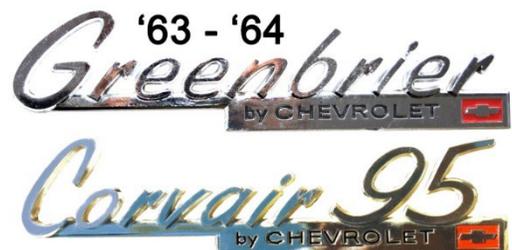
The ‘61 - ‘62 emblems used scripted lettering. The Greenbrier emblem for these years is the only one that was entirely chrome, whereas the Corvair 95 emblem is staged on a red bar.

The names were italicized for ‘63 and ‘64 emblems. Below the names a half-length chrome banner was engraved with “by Chevrolet”, painted black, and chased by the Chevy bowtie in a recessed red rectangle.

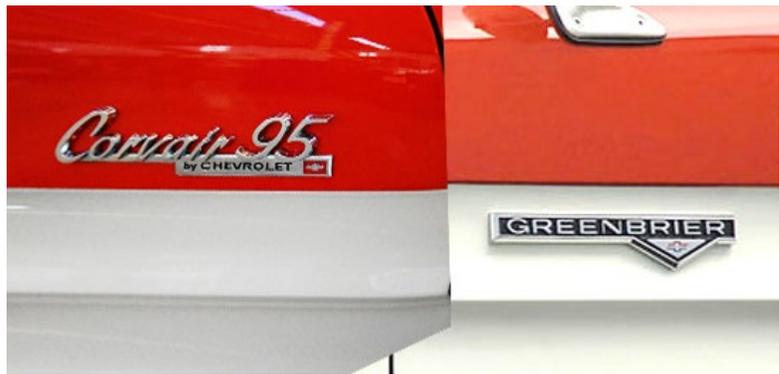
The emblem of '65 Greenbriers is distinctive on several accounts. The name in block letters is embossed on a black banner above a small right-justified triangle with a red and blue bowtie logo. Additionally, unlike the previous four years, the emblem placement was moved down into the upper of the door panel double coves.

Emblem location 1961 - '64 (left) and in 1965 (right).
