# Running changes in 1964 Corvair Cars

This is a work in progress which attempts to document known running changes in Corvair cars for the 1964 model year. I am not noting changes in specifications or part numbers, just changes that affect the appearance or operation of the vehicles. I attempt to indicate the approximate date that such changes took place, based on my own research of original cars and study of documents, but I indicate with a question mark when I am uncertain or more study is needed. Photos of before and after changes are imbedded in the document.

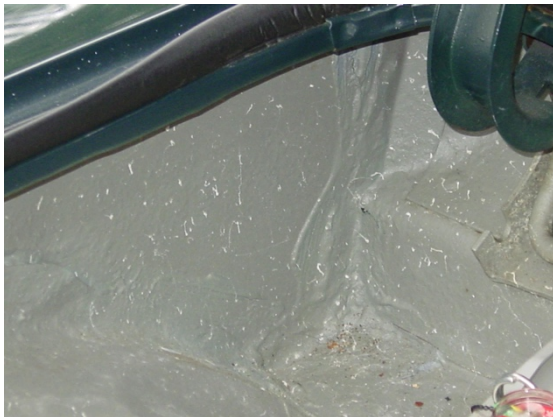
**09C: Trunk Vents** – the vents in the right and left rear corners of the trunk were changed to stamped louvered vents. The exact date of the changeover occurred early in the 1964 model year – all cars built before 09C have the earlier style.

Right Rear Trunk Corner – late '63-early '64

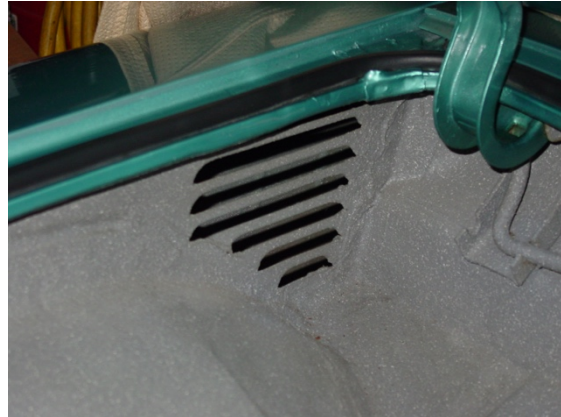
Right Rear Trunk Corner – 09C 1964

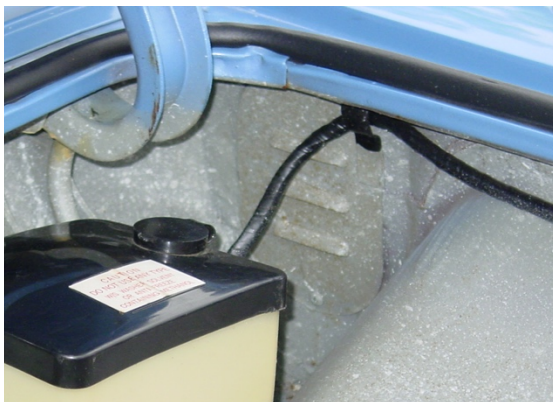
Left Rear Trunk Corner – 1961-early 1964

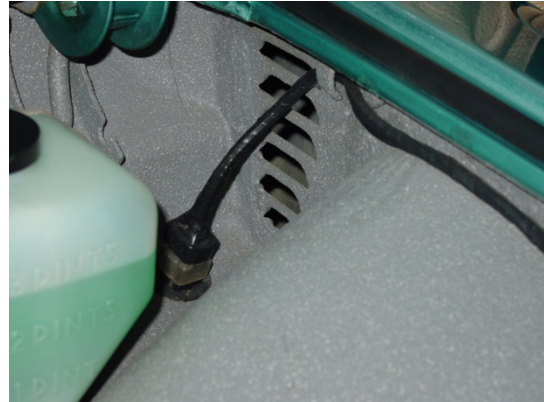
Left Rear Trunk Corner – 09c 1964

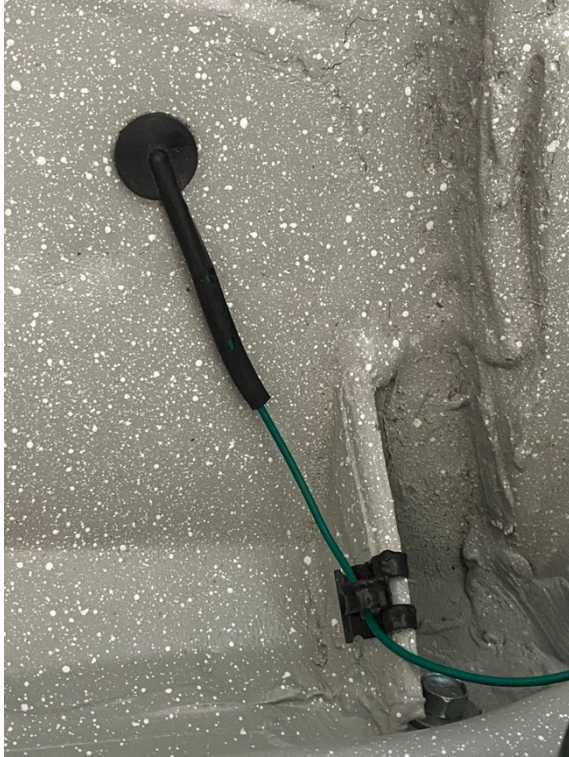
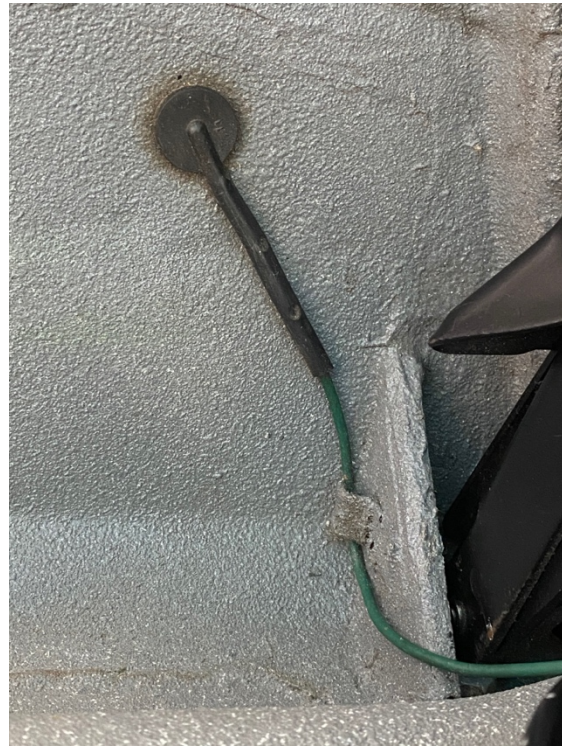
At the beginning of the model year a separate clip held the horn wire to the body seam in the trunk floor; later on the clip was changed to a welded tab that could be bent over the wire:

09C Horn wire clip

04A Horn Wire clip

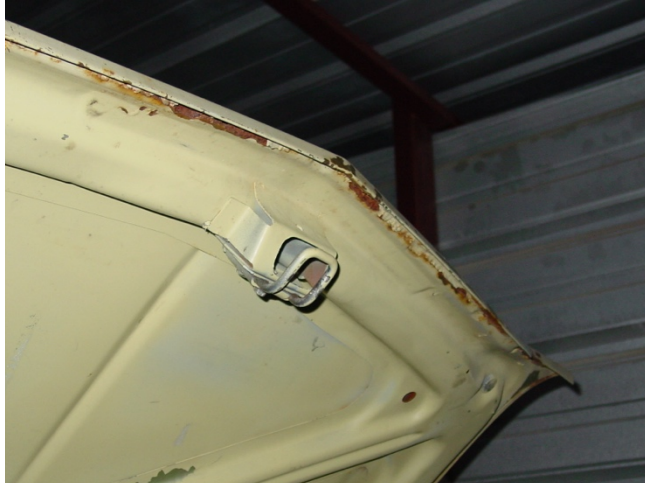
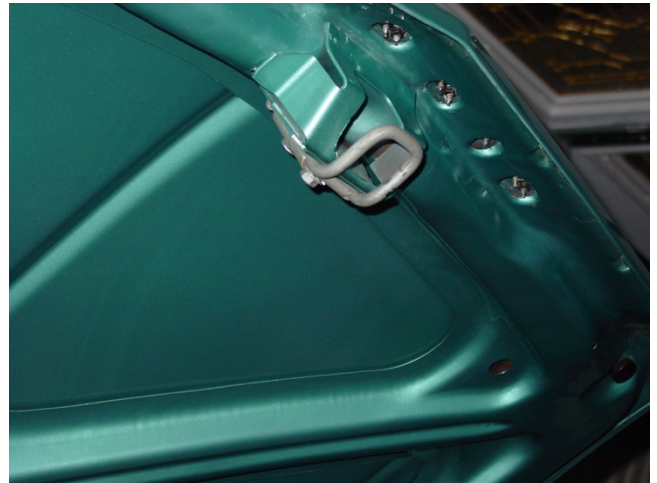
**12B? Trunk Lid Letters:** The C O R V A I R letters on the trunk lid were initially of the push-in style (same as on the Deck lid), but due to issues with water getting under them and causing rust, were converted to screw-in style sometime around mid-December of 1963. We have found some cars with later build dates (up to 02D) with the push-in style, but no cars earlier than 12B with the screw-in style. It's thought that the changeover probably occurred around 12B but excess inventory was used up on a few later builds.

09C Trunk Lid with push-in letters

04A Trunk lid with screw-in letters

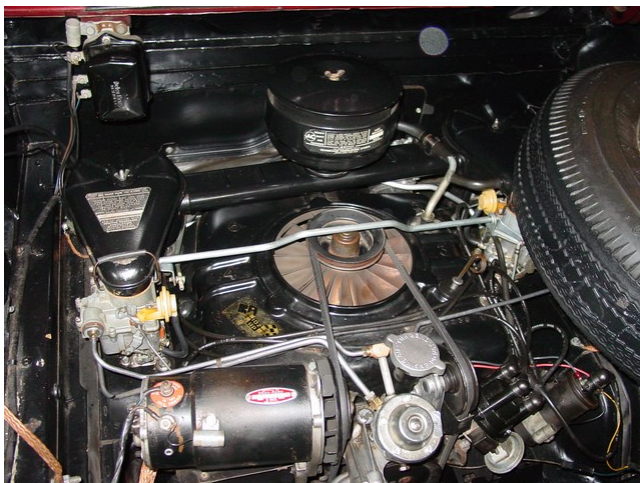
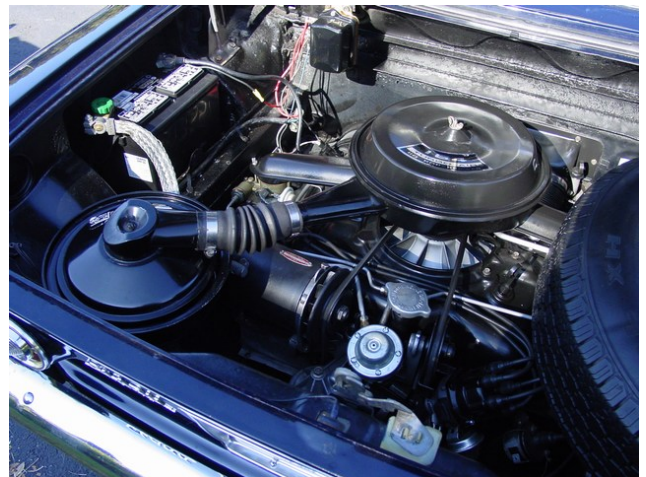
**01A? Oil Bath Precleaner** – Originally the same as the 1963 style with dual air cleaners, this changed to the late model style around the beginning of 1964. The exact date will probably never be known, as many of these were added or removed over time and there is no documentation of the option on the car itself. It would be nice to have documentation from original cars with known history.

10C Oil Bath Pre-Cleaner

05C Oil Bath Pre-Cleaner

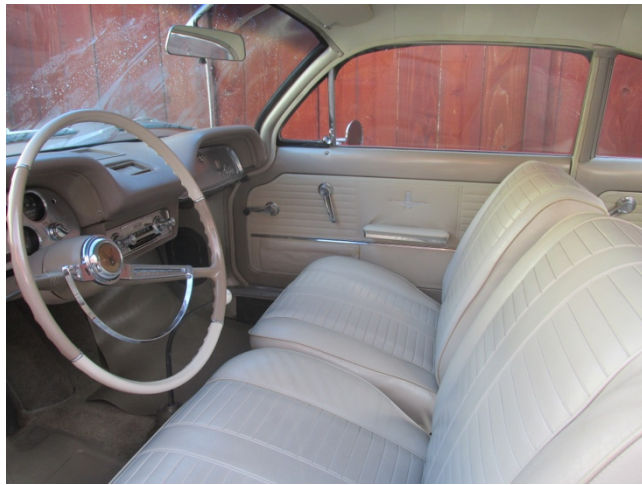
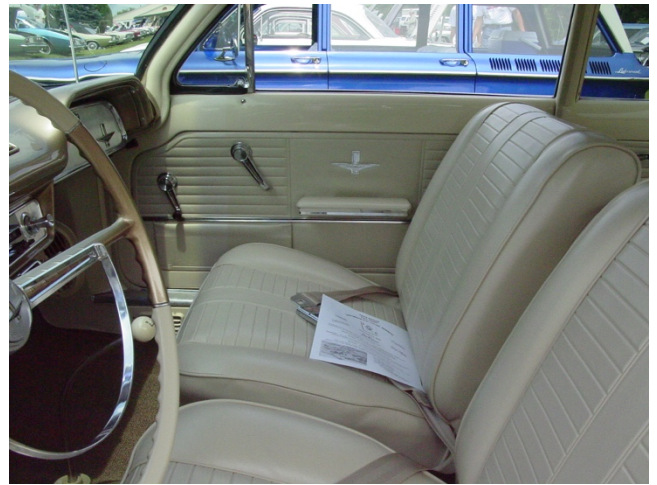
**01A? Fawn Interior** (Fisher interior Paint code F): The exact date or reason for the change is not precisely known, nor is it documented in any literature we've found, but it appears that all cars with Fawn interiors built in the first part of the model year (so far up through 11D) use Medium Fawn paint to trim the doors and rear quarters, whereas all cars from 01A onwards use Light Fawn to trim those area

10C Fawn Interior

04C Fawn Interior

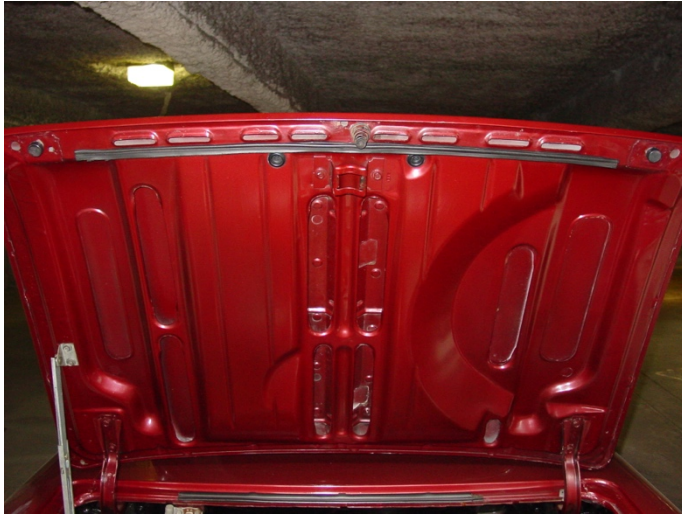
**02A? Deck Lid Vents and Weatherstrip:** Modification made to the rear under end of the Deck Lid to close off 6 of the 8 drainage holes and elongate the rear weatherstrip to reduce the likelihood of tailpipe emissions being drawn back into the engine compartment. The earliest car I've seen with this change has body code 02A, with some as late as 04A still with the original style.

01C Deck Lid with 8 drain holes and shorter weatherstrip

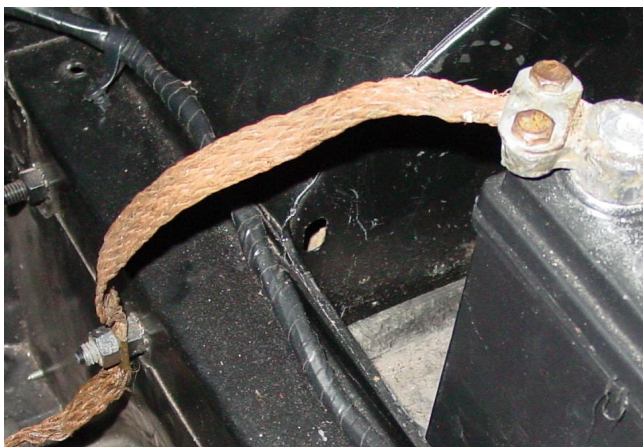
**02C? Vented Battery caps** These were added right around the same time as the Deck Lid modifications, to eliminate possibility of battery acid fumes being drawn into the heater system. Cars with this modification can be identified by the presence of the small oval hole in the right rear wall of the battery box (for the hoses). As with the deck lid changes, there is some variability in the date codes: the earliest code with the hole is 02C, whereas the latest without the hole is 02D

04A Battery Box with oval hole for battery vent hoses
