# Corvair 95: Stock was. . .

## 5 - Outside Rear View Mirrors

By Steven Spilatro

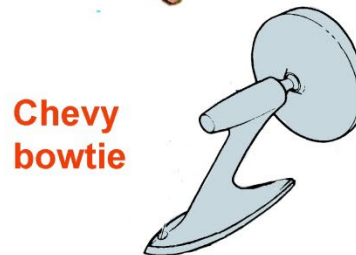
Chevy bowtie

This is essentially the same chrome mirror as used on the cars with a face diameter of 4 ¾ inches. The availability – and suitability – of this mirror for the FC has long been a mystery, and once again I'm indebted to Dave Newell for helping with the research.

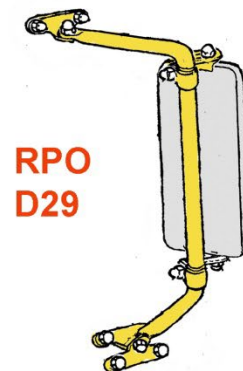
RPO D29

This mirror (#3818422) was introduced in 1964 and available as either a factory-installed RPO (D29) or a dealer-installed accessory. Compared to the '61 –'63 west coast style mirror, this was a smaller (10" X 6") less accident-prone version, but also less ruggedly constructed, with no diagonal brace. Unlike its larger predecessor, both the mirror face and the bracket were shared with other Chevrolet trucks. According to the truck engineering specifications book, as an RPO the bracket would have been painted the body color and the head was black, but both were cameo white as a dealer-installed accessory. The same accessory mirror (#985410, superseded by #985771 in '64) was used for the Corvair 95 and C10 – C30 Chevy trucks.

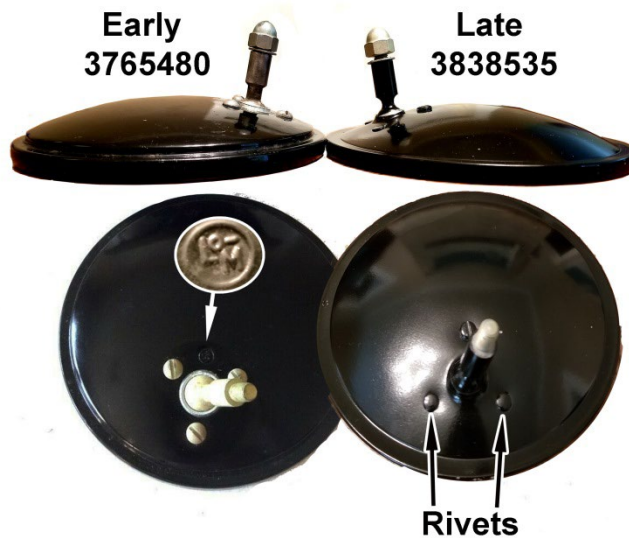
Then, in late 1962 or with the 1963 production year, when the mirror became RPO D32, the mirror head was modified (now #3838535). The new mirror head had some modifications to the stamping of the sheet metal, was slightly thinner than the earlier

version, and used two rivets and a screw used to secure the mounting bracket. [Thanks to Thomas Pedigo for providing the pictures.]

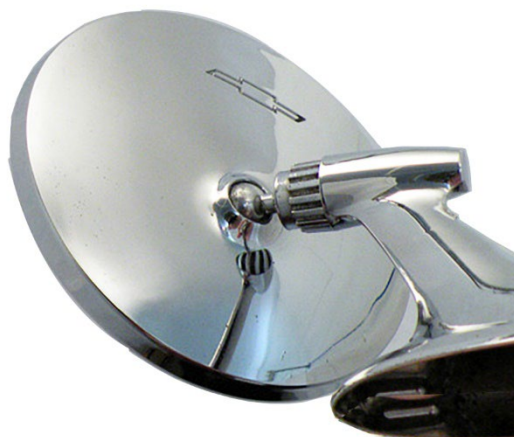
Considering they were poorly suited for the Corvair 95, why was the bowtie mirror an option? Larry Claypool suggested this mirror may have been offered by default for the Greenbrier since they were classified as a passenger suburban vehicle. However, Accessory Installation Manuals identify them for all "Corvair 95" models. Nevertheless, it appears that this mirror was the first mirror made available for the Corvair 95 line. Dave Newell has provided a copy of the installation instruction sheet for

the #988471 mirror, which is dated 6-21-60 (3783629 is the part number of the instruction sheet itself). Since the timeline for the introduction of RPO 210 with the 3¾" arm began around 10/5/60, the planning for the bowtie mirror predated that of RPO 210.
