# Running changes in 1964 Corvair Cars

This is a work in progress which attempts to document known running changes in Corvair cars for the 1964 model year. I am not noting changes in specifications or part numbers, just changes that affect the appearance or operation of the vehicles. I attempt to indicate the approximate date that such changes took place, based on my own research of original cars and study of documents, but I indicate with a question mark when I am uncertain or more study is needed. Photos of before and after changes are imbedded in the document.

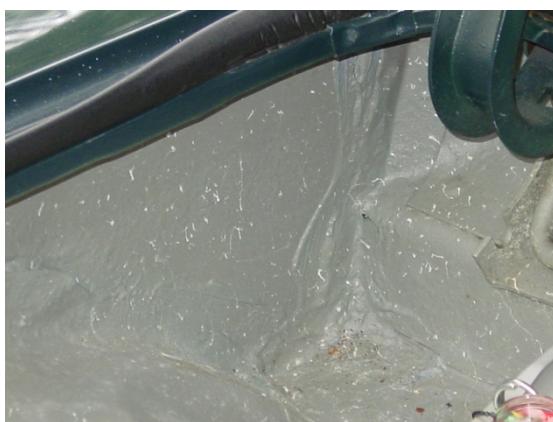
Right Rear Trunk Corner – late '63-early '64

**09C: Trunk Vents** – the vents in the right and left rear corners of the trunk were changed to stamped louvered vents. The exact date of the changeover occurred early in the 1964 model year – all cars built before 09C have the earlier style.

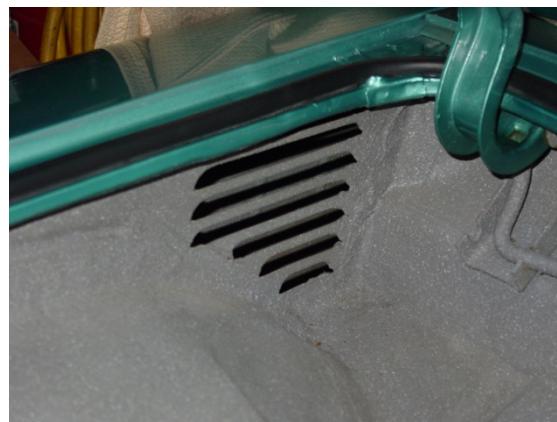
Right Rear Trunk Corner – 09C 1964

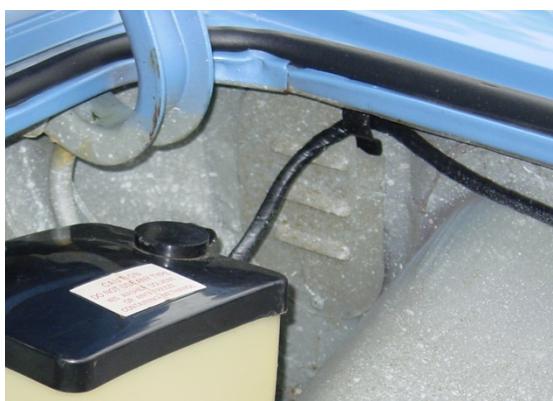
Left Rear Trunk Corner – 1961-early 1964

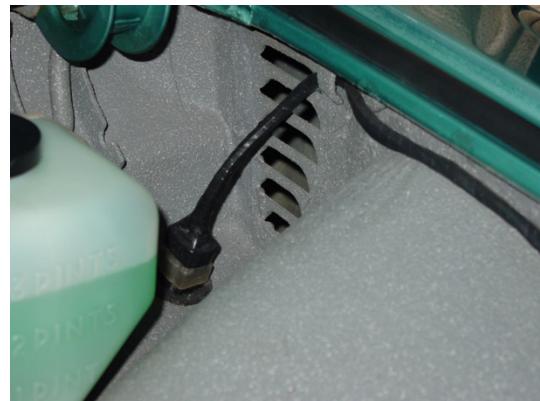
Left Rear Trunk Corner – 09c 1964

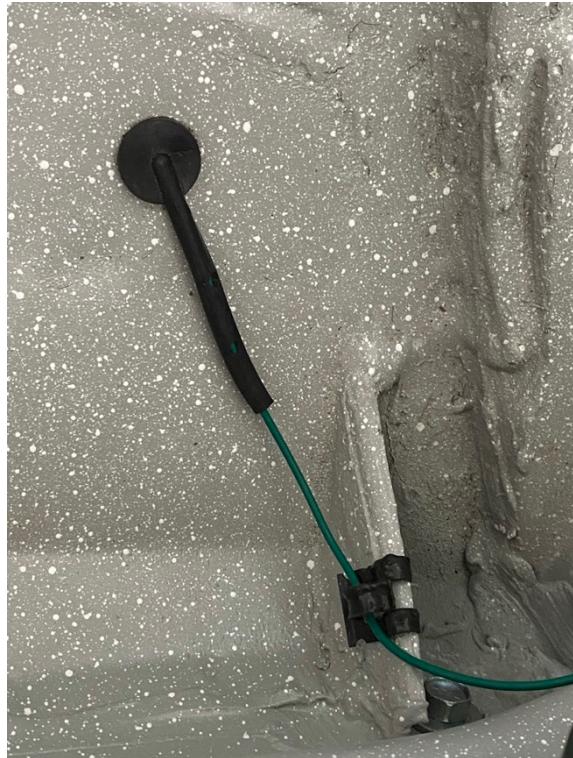
09C Horn wire clip

At the beginning of the model year a separate clip held the horn wire to the body seam in the trunk floor; later on the clip was changed to a welded tab that could be bent over the wire:

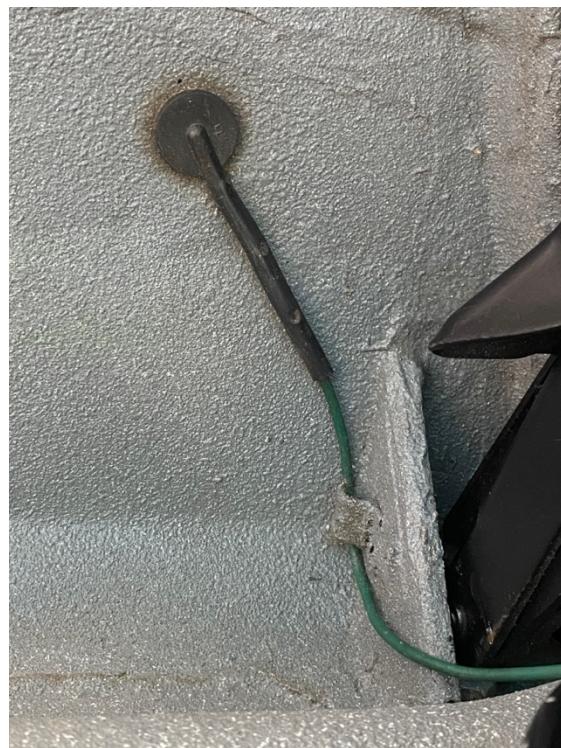
04A Horn Wire clip

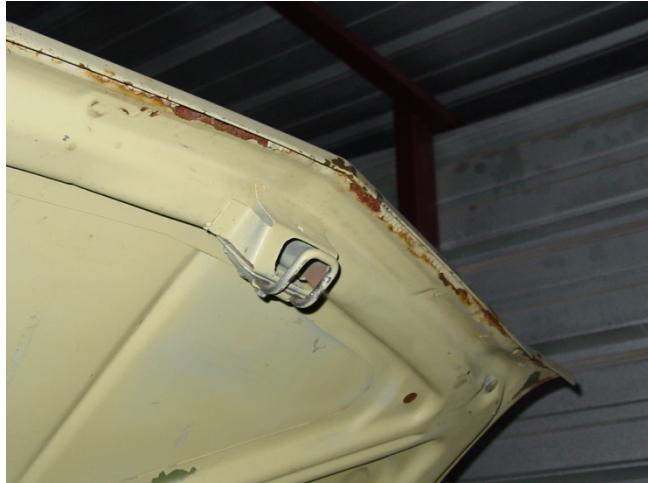
09C Trunk Lid with push-in letters

**12B? Trunk Lid Letters:** The C O R V A I R letters on the trunk lid were initially of the push-in style (same as on the Deck lid), but due to issues with water getting under them and causing rust, were converted to screw-in style sometime around mid-December of 1963. We have found some cars with later build dates (up to 02D) with the push-in style, but no cars earlier than 12B with the screw-in style. It's thought that the changeover probably occurred around 12B but excess inventory was used up on a few later builds.

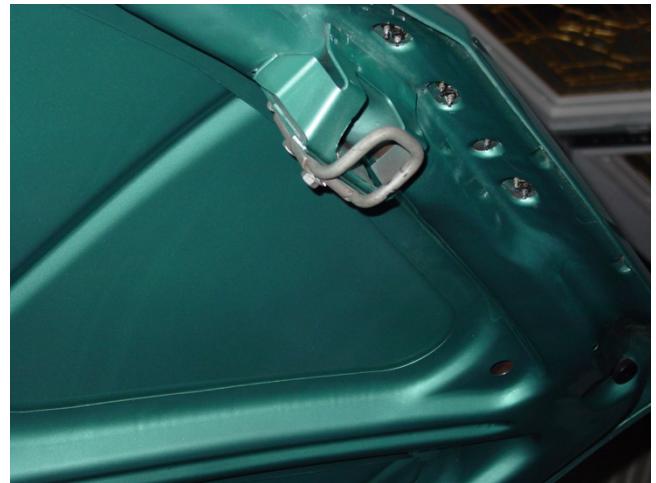
04A Trunk lid with screw-in letters

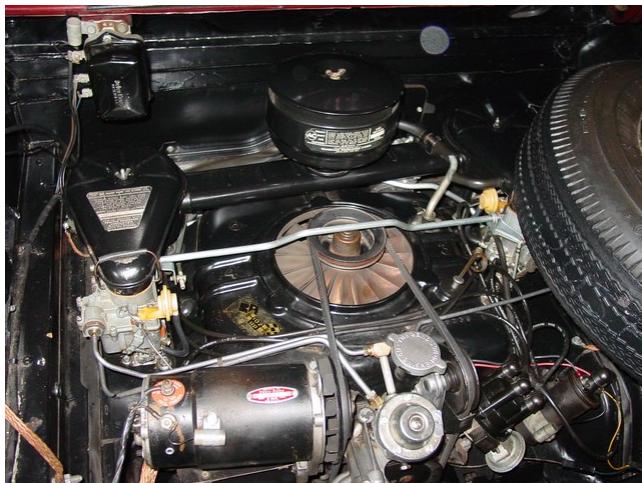
10C Oil Bath Pre-Cleaner

**01A? Oil Bath Precleaner** – Originally the same as the 1963 style with dual air cleaners, this changed to the late model style around the beginning of 1964. The exact date will probably never be known, as many of these were added or removed over time and there is no documentation of the option on the car itself. It would be nice to have documentation from original cars with known history.

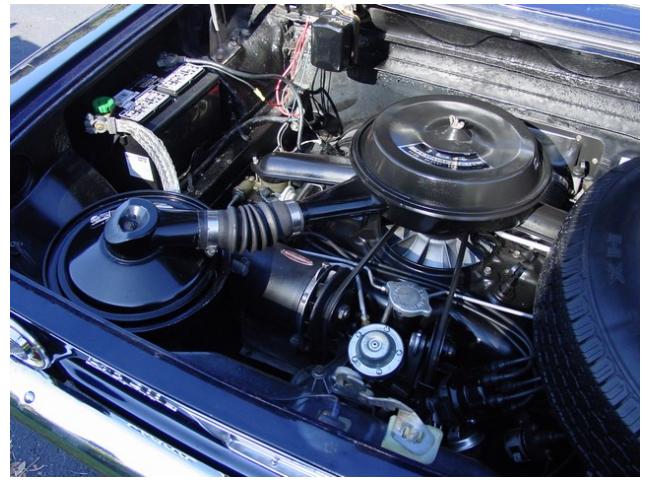
05C Oil Bath Pre-Cleaner

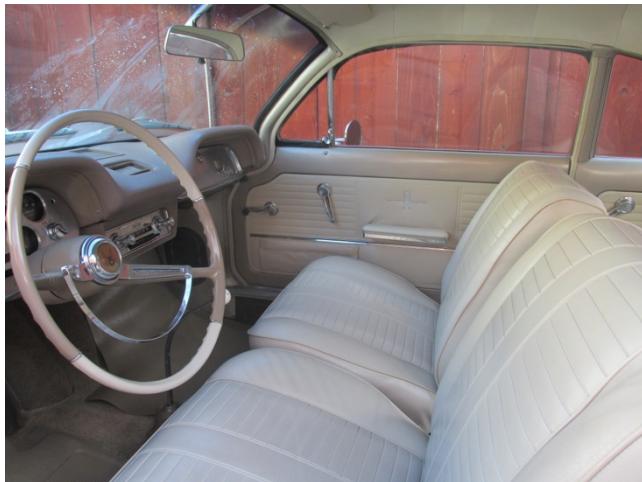
10C Fawn Interior

**01A? Fawn Interior** (Fisher interior Paint code F): The exact date or reason for the change is not precisely known, nor is it documented in any literature we've found, but it appears that all cars with Fawn interiors built in the first part of the model year (so far up through 11D) use Medium Fawn paint to trim the doors and rear quarters, whereas all cars from 01A onwards use Light Fawn to trim those area

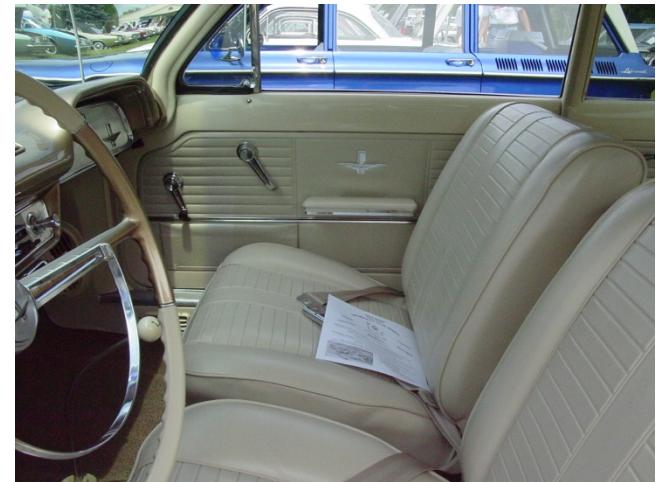
04C Fawn Interior

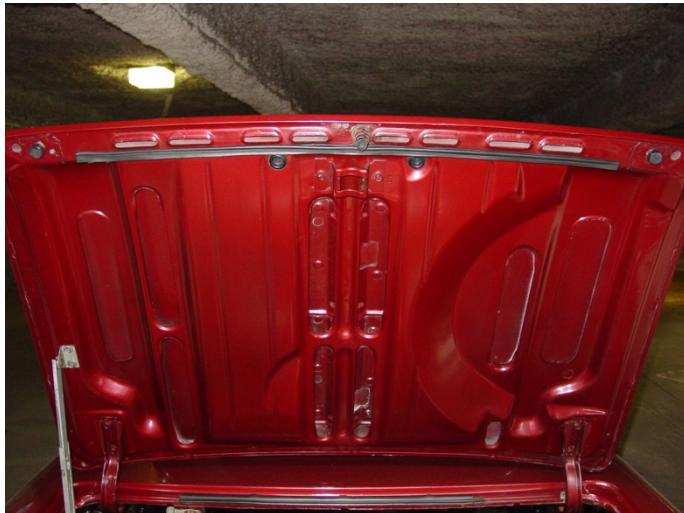
01C Deck Lid with 8 drain holes and shorter weatherstrip

**02A? Deck Lid Vents and Weatherstrip:** Modification made to the rear under end of the Deck Lid to close off 6 of the 8 drainage holes and elongate the rear weatherstrip to reduce the likelihood of tailpipe emissions being drawn back into the engine compartment. The earliest car I've seen with this change has body code 02A, with some as late as 04A still with the original style.

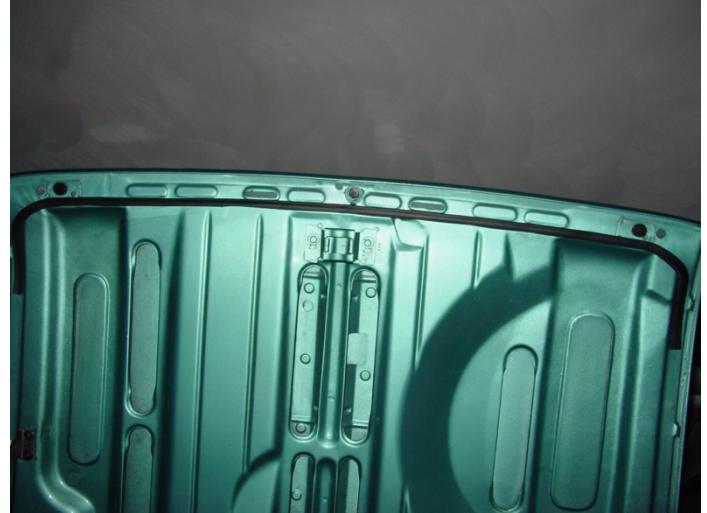
04A Deck Lid with 2 drain holes and longer weatherstrip

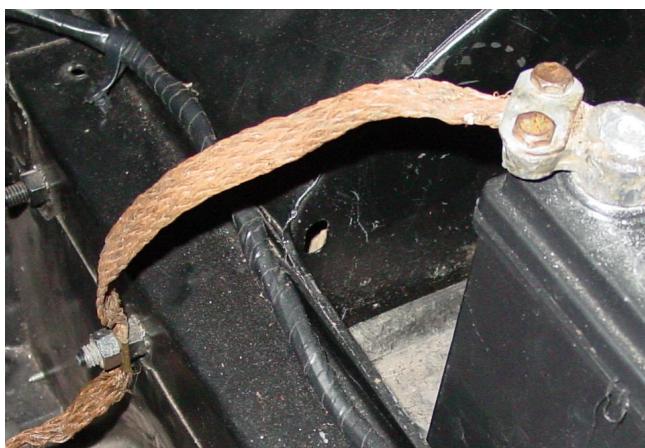
04A Battery Box with oval hole for battery vent hoses

**02C? Vented Battery caps** These were added right around the same time as the Deck Lid modifications, to eliminate possibility of battery acid fumes being drawn into the heater system. Cars with this modification can be identified by the presence of the small oval hole in the right rear wall of the battery box (for the hoses). As with the deck lid changes, there is some variability in the date codes: the earliest code with the hole is 02C, whereas the latest without the hole is 02D
